RAILWAY ACCIDENT INVESTIGATION UNIT (RAIU)

## ANNUAL REPORT

2017

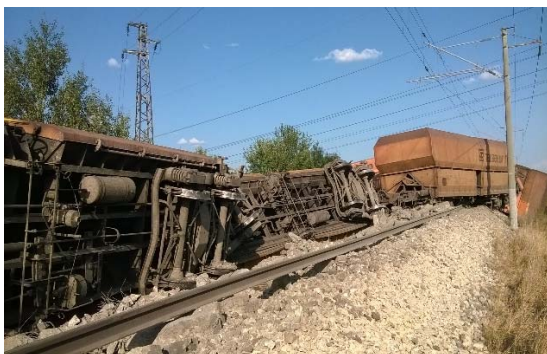
At 4:10 p.m. the train passed at speed 70km/h on the third main line at Petarch station. After its transition through arrow № 2 there was a crashing noise and the train stopped. On site inspection, the on-duty stationary switchman established that seven wagons derailed and lied down from the composition of the train (from fourth to tenth), and the carried cargo was scattered.

As a result of the derailment of the train there were no victims. There were material damages on the railway rolling stock, railway infrastructure and the carried cargo.

The immediate technical reason that caused the derailment of the train was the detachment of the retainer for axle-box spring, holding the outer and inner springs for the wing of the left axle-box of the second axle shaft of the first cart of fourth wagon in direction of the train movement.

| 2017 |
|---|
| <p><b>Event: Derailment of freight train № 50505 when passing through Petarch train station on 28.08.2016</b></p> <p>Safety recommendations: (02.02.2017)</p> <ol style="list-style-type: none"> <li>1. The railway carrier BDZ Freight Services Ltd shall increase the control over the correct loading of the carriages in the areas for loading and unloading bulk goods.</li> <li>2. Improve the quality of the technical inspections conducted by the technical staff of the carrier BDZ Freight Services and Bobov Dol Power Plant EAD - the owner of the carriages utilized on the railway infrastructure.</li> </ol> <p><i>Adopted measures</i></p> <p>Recommendations 1 and 2 have been implemented.</p> |

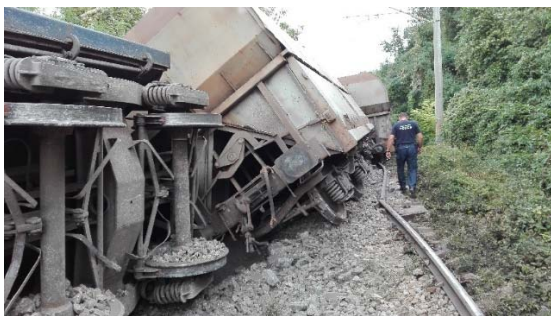
At the request of “BSR – Freight Transport” Ltd. on 03.09.2016 was assigned a freight train № 10690, containing of 18 full wagons (coal), 72 axes and gross mass 1348 tons, serviced by electric locomotive № 46033.7. with a route Plovdiv-shunting yard – Plovdiv – Sofia - Voluyak. The train arrived at Iskar station at 5:00 a.m. and after changing the locomotive brigades, it left for Voluyak station at 5:20 a.m. The train stayed 6 min. at Voluyak station due to change in the train number and change in the brake mass certificate, and implementation of the abbreviated sample “D” of the automatic train brake. The train left Voluyak station under № 50501 in direction Voluyak – Razmenna – Batanovtsi - Dupnitsa. During the movement of the train in the interstation Voluyak – Hrabarsko on km 14+055, wagon № 31 52 665 1221-1 ,twelfth in line in the composition, derailed, with the first axle shaft of the first cart of the wagon, on the right of the direction of movement and continued its movement, and as a result the second axle shaft on the right derailed. In this condition (with derailed first cart), the train continued moving and the locomotive brigade did not notice or feel this. When the train entered a curved line on the railway road with radius R-500 m from km 23+164 to km 24+830, after the twelfth wagon, five more wagons of the train derailed from 13<sup>th</sup> to 17<sup>th</sup> and at the same time the train breaks between fifth and sixth, and between eleventh and twelfth wagon.

The caused damage on the rolling stock and the railway infrastructure from its interruption amounted to 484153 BGN.

The intermediate technical reason that caused the accident was: Incorrect loading and distribution of the loose cargo in twelfth wagon in the train, as a result of which the central gudgeon of the first cart worked aggressively during the movement and the entry of the cart was hampered, which had led to the lifting of the right wheel of the first axle shaft of the first cart of the head of the rail without any trace.

| 2017 |
|---|
| <p><b>Event: Derailment of six full carriages of freight train No. 50501 between the train stations Voluyak and Hrabarsko.</b></p> <p>Safety recommendations: (08.02.2017)</p> <ol style="list-style-type: none"> <li>1. The railway carrier BDZ Freight Services Ltd and the consignors of bulk goods shall construct weight-measuring devices for the vertical loading of each wheel of the freight carriages in the areas where the loading and unloading activities are performed.</li> </ol> |

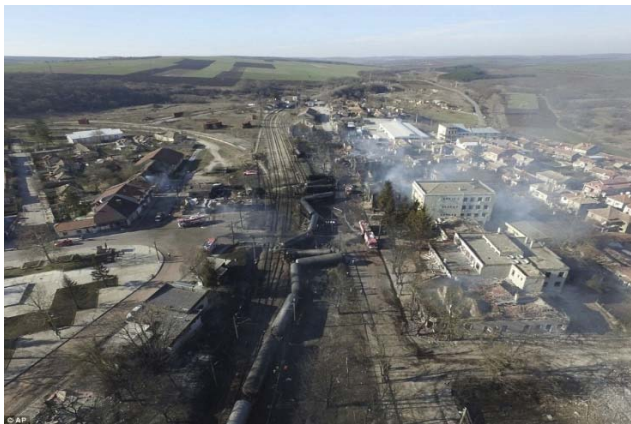
As a result of the derailment, the balloon of the tenth tank-wagon was pierced (№ 33877915652-4), from which the carried cargo (propylene) leaked and ignited. There was a big fire which covered a significant area of the village.

The total amount of the damage and expenses for the recovery of the rolling stock, railway infrastructure and interruption of the accident was: 3 238 891,13 lv.

1. The Railway Administration Executive Agency shall recommend the heads of the railway carriers and the Director-General of the National Railway Infrastructure Company to give lectures to the staff on the safety of the transport, to familiarize themselves with the content of the final report from the conducted investigation.

3. The Railway Administration Executive Agency shall order the cancellation of the possibility for the owners of carriages carrying dangerous goods to take a decision themselves about the duration of the period between the repairs of the running gear, the chassis and the traction and deflection facilities, which is currently 4 or 6 years and also to stipulate the repairs to be conducted every 4 years like the requirements towards the tanks carrying dangerous goods which are included in the RID Regulations.

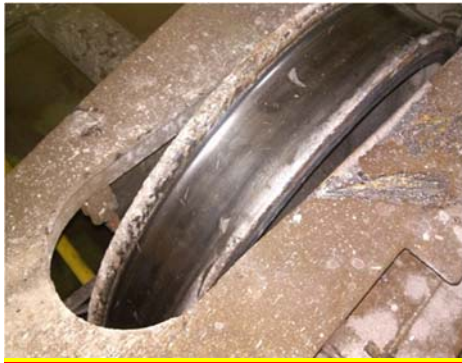
On 09.02.2017 a full tank-wagon of propane-butane from the composition of freight train № 30582, serviced by Bulgarian Railway Company SOJSC, derailed with its first cart on road № 2 in the interstation Dulgopol - Komunari. The locomotive brigade did not notice the derailment. When the train entered Komunari station and after crossing arrows № 101, 3 and 5, the tank-wagon went up again on the rail road.

As a result of the accident there were no victims but serious material damages were caused on 4 477 m of the rail road, on arrows № 101, 3 and 5 and on the derailed wagon. The staff and passengers were not injured.

The reason which led to the accident was an obviously moved center of the gravity of the tank-wagon in transverse direction, visible from the established two-sided gaps in the sliding of the two carts and the basket, as well as the loosening of the press assembly of a wheel-axis, which disturbed the distance between the bandages of the first leading axle shaft of the wagon and this made it difficult for the cart to enter the curved line in the rail road.

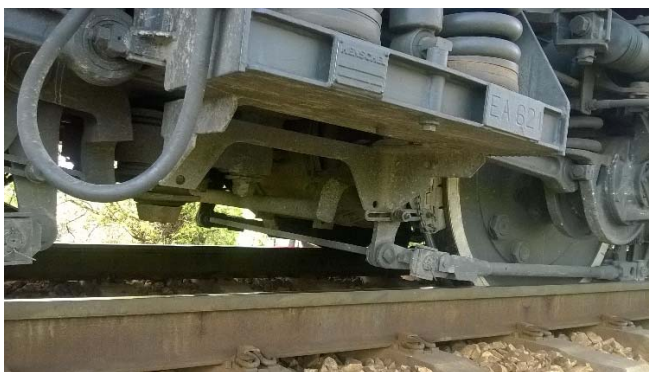
On 04.05.2017 freight train № 30690, serviced by railway carrier “DB Cargo Bulgaria” Ltd., was moving on route Burgas – Karlovo – Pirdop with three locomotives, two of which in off-day (cold) condition and 23 empty wagons. In front of the entry signal at Pirdop station, the second locomotive № 86018.9 derailed with the first axle shaft. The derailment was a result of a broken axis on the first axle shaft.

The material damages on the locomotive and railway infrastructure amounted to 39 200 BGN.

The reason which led to the accident was a break in the first axle shaft in the direction of movement of locomotive № 86018.9 in the area of the transition to the back of the head-stock, resulting in weariness of the material and presence of multiple cracks on the outer surface of the axis.
