REPUBLIC OF BULGARIA
NATIONAL AIR, MARITIME AND RAILWAY TRANSPORT ACCIDENTS
INVESTIGATION BOARD

ANNUAL REPORT

NATIONAL RAILWAY TRANSPORT ACCIDENTS
INVESTIGATION BOARD

2022

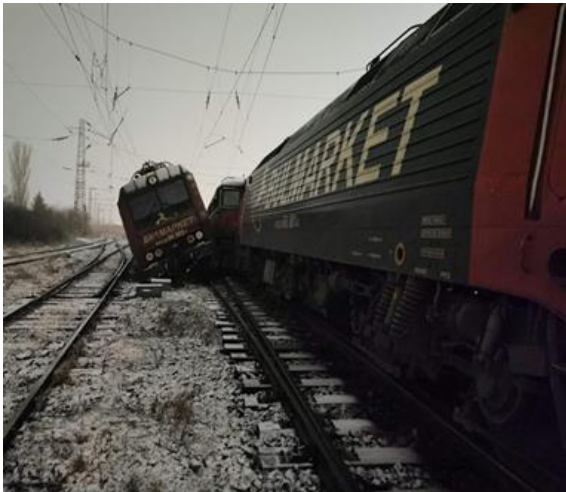
At 03:13 a.m., DFT No. 20698 with locomotive No. 91522086005-9 also departed from the ninth track at Ilyiantsi station, without a permissive indication of the signalling from the ninth track for Svetovrachene station in the direction of Pirdop station. At the time of departure, the first-person locomotive driver was alone in the locomotive control cabin. During that time, the second-person locomotive driver was in the engine compartment of the locomotive. When the locomotives of the two trains on switch No. 39 entered at the same time, they collided sideways and derailed to the left and right of the railway switch with all wheel sets.

Because of the derailment of the train, severe damage was caused to the two locomotives, to the railway infrastructure - railway track, railway switches, overhead contact line and signalling equipment. The movement of trains through Ilyiantsi station was not interrupted.

Track 9 at Ilyiantsi station was found to be located to the right of track 8 in the direction of increasing mileage, with most of track 9 running parallel to track 8 from south to north, with a wheelbase of 4.83 meters, after which the 9th track deviates to the right with a right curve and a left counter curve and the wheelbase between the two tracks increases to 6.58 meters. The two exit semaphores for tracks 8 and 9 are ground level.

The Investigation Commission found that when looking from the locomotive driver's cabin from the place where locomotive No. 91522086005-9 was located on the 9th track, it was quite possible that the locomotive driver mistakenly took the clearance reading of the

ground signal given for the 8th track exit semaphore for DFT No. 20691. This circumstance cannot be considered as the main cause for the accident, since the legal documents and the technology of Ilyantsi station forbid the locomotive driver to leave the station only upon a permissive indication of the exit semaphore, but it is probably influenced to a certain extent.

Therefore, as the direct cause of the accident, it can be considered that DFT No. 20698 departed from the ninth track without fulfilling the regulatory requirements for sending a train from Ilyantsi station.

Recommendation 1, proposes SE NRIC and "Bulmarket Rail Cargo" EOOD to familiarize the interested personnel with the contents of the report.

Recommendation 2, proposes "Bulmarket Rail Cargo" EOOD to assess the psychological human factor of the locomotive staff in order to improve teamwork in a positive atmosphere.

Recommendation 3, proposes that "Bulmarket Rail Cargo" EOOD periodically hold talks with the locomotive staff in the presence of a psychologist, at which the development and validation of collective good practices will be discussed.

Recommendation 4, proposes that RAEA evaluates the functioning of the Safety Management Systems in terms of carrying out pre-shift briefings and checking for alcohol and other intoxicating substances of the locomotive staff in the railway enterprises carrying out freight and passenger transport and, at the discretion and need, to restore the points for carrying out pre-trip medical examinations.

Recommendation 5 proposes in the event that, when assessing the functioning of the Safety Management Systems of railway undertakings, inconsistencies or omissions are found regarding compliance with the requirements of item 4.2. *Competences* and item 4.6 *Integration of the human and organizational factor from Annex 1 of Delegated Regulation (EU) 2018/762 of the Commission*, RAEA to issue mandatory instructions to railway undertakings to organize staff training for the formation of mechanisms such as stress resistance, working out personal stability and dynamic balance of the psychological state, building and playing off a subjective sense of control.

Recommendation 6 proposes that RAEA carry out an inspection regarding the types of signalling at Ilyantsi station and, together with SE NRIC, take actions to comply with the requirements of art. 305 of Ordinance No. 58.

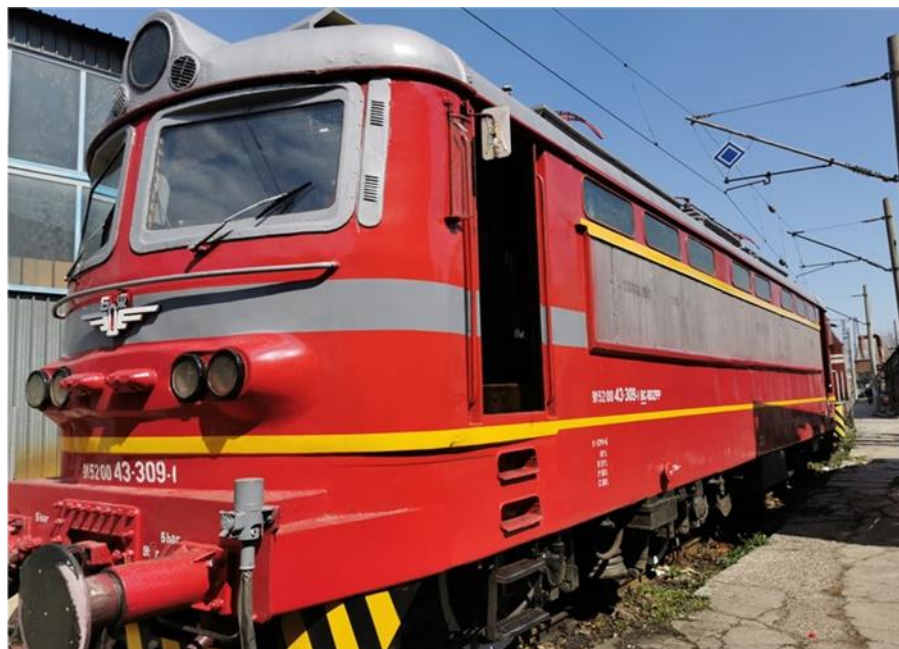
In the course of the tests carried out by competent experts, they found that the train heating of the locomotive was not working. The head of the workshop ordered the Organizer of production and repair of railway transport, master, to eliminate the identified malfunction in the locomotive. The supervisor got off the locomotive, took the necessary tool and returned to the locomotive to remove it. During the elimination of malfunctions, violations of the normative and inter-departmental acts (regulations, rules and instructions) regulating safe working conditions when working with electrical devices in locomotives were committed.

As a result of non-compliance with the regulations and lack of coordination in the actions between the experts performing the functional tests and the employee troubleshooting the train heating of the locomotive, the pantograph was lifted without warning, which resulted in an electrocution with a fatal outcome (to the Organizer of production and repair of RRS, master).

The direct cause of the fatal accident was electrocution of the employee (during troubleshooting in the engine compartment of the locomotive) by an electric shock with an alternating current of voltage 1500 V, 50 Hz, which flowed through the power circuit of the train heating as a result of uncoordinated actions of those involved experts in locomotive testing (lifting the locomotive pantograph and turning on 25 kV voltage, without disclosure).

With recommendation 1, it is proposed that BDZ PS EOOD and BDZ Cargo EOOD conduct an extraordinary briefing for the personnel in the repair and operation of railway transport and familiarize them with the final report of the NAMRTAIB on the railway accident that occurred.

With recommendation 2, it is proposed that BDZ PS EOOD and BDZ Cargo EOOD conduct refresher training for the personnel in the repair and operation of public transport vehicles for the safety measures under Ordinance No. 7 and Ordinance No. 13.

With recommendation 3, it is proposed BDZ PS EOOD and BDZ Cargo EOOD to make amendments and additions to the normative documents regulating the types of repairs of TPRS (Regulations for the organization of repair activities in locomotive depots, Instructions for safe work when servicing electric locomotives and motor trains in locomotive depots; Regulations for depot repair and maintenance of BDZ electric locomotives and tests with which TPRS is accepted and handed over for repair as necessary).

With recommendation 4, it is proposed that BDZ PS EOOD and BDZ Cargo EOOD change the work instructions and PLC, which will guarantee increased control by the officials during the execution and acceptance of the repair works, checking of the protective interlocks of the locomotives, ensuring traceability and nominal responsibility.

With recommendation 5, it is proposed BDZ PS EOOD and BDZ Cargo EOOD to create order and organization after coming out of repair and during operation, upon acceptance of the locomotive, the locomotive crews shall check and enter in the logbook the status of all protective locks of the locomotives.

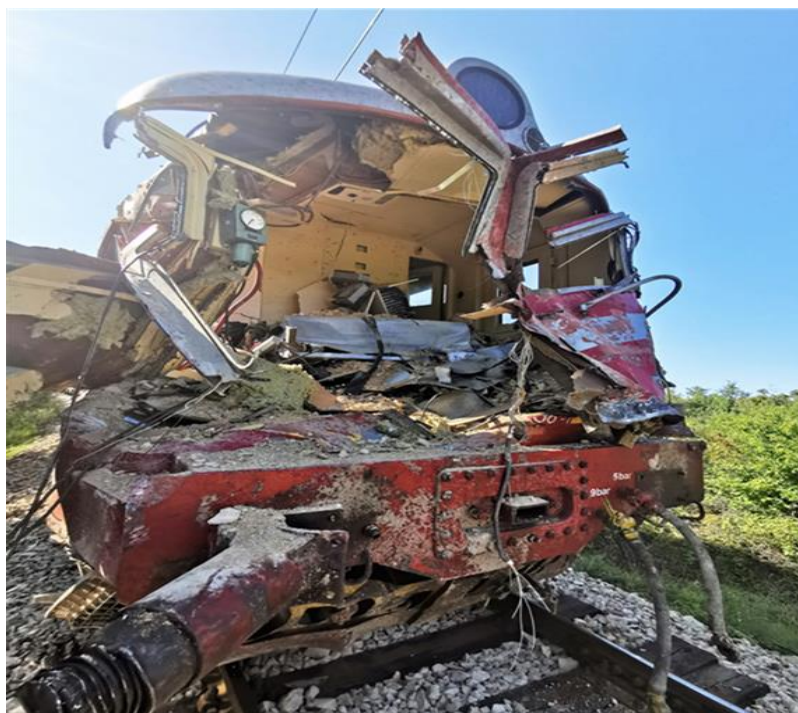
Because of the collision, the driver of the car was killed and fell from the cab of the car, and the heavy goods vehicle was thrown from the locomotive to the right in the direction of the movement of the train 20 meters after the level crossing with a destroyed cab. From the subsequent collision, the cab of the locomotive was severely deformed and the two locomotive drivers were killed. Three passengers from the train were slightly injured. Two were given medical aid at the Vidin General Hospital and were released; the third passenger was given medical aid on the spot and released. The injured passengers were traveling in the first passenger coach next to the locomotive with № 51522563027-3, which derailed with both track wheel sets of the first bogie and one-track wheel set of the second bogie.

The accident was caused by the illegal passage of the loaded heavy goods vehicle "Iveco" through the railway level crossing at km 127+123 in the Dimovo - Oreshets interstation in front of the approaching FT No. 7623. The ALCS was activated, a prohibitory

With recommendation 1, it is proposed that SE NRIC and "BDZ-Passenger Services" EOOD inform the interested personnel with the content of the report.

With recommendation 2, it is proposed that the National Safety Authority RAEA organize and propose amendments and additions to Ordinance No. 4 of 27.03.1997 on railway level crossings, that a representative of the State Agency Road Safety is included in the commission under chapter five of the Ordinance of road traffic.

With recommendation 3, it is proposed that the National Safety Authority RAEA organize and propose an amendment and addition to Ordinance No. 4 of 27.03.1997 on railway level crossings, regarding updating the categorization of level crossings, on the main railway lines railway level crossings equipped with ALCS, to re-equipped with automatic semi-barriers (ALCS).

With recommendation 4, it is proposed that the SE NRIC develop a program for the phased re-equipment of level crossings equipped with ALCS in the interstation of the main railway lines with automatic semi-barriers (ALCS), after amending and supplementing Ordinance No. 4 to update the categorization of level crossings.

With recommendation 5, it is proposed that SE NRIC gradually build 24-hour video surveillance covering the passing flow of road vehicles and rolling stock through the level crossings located on the main railway lines.

With recommendation 6, it is proposed that the Municipality of Dimovo restore and maintain the missing road signs A33 (railway crossing without barriers) and A35 (balises) from the two road approaches to the railway crossing at km 127+123 in the Dimovo - Oreshets interstation in accordance with the requirements of PPZDvP and Ordinance No. 4/27.03.1997 on railway crossings.

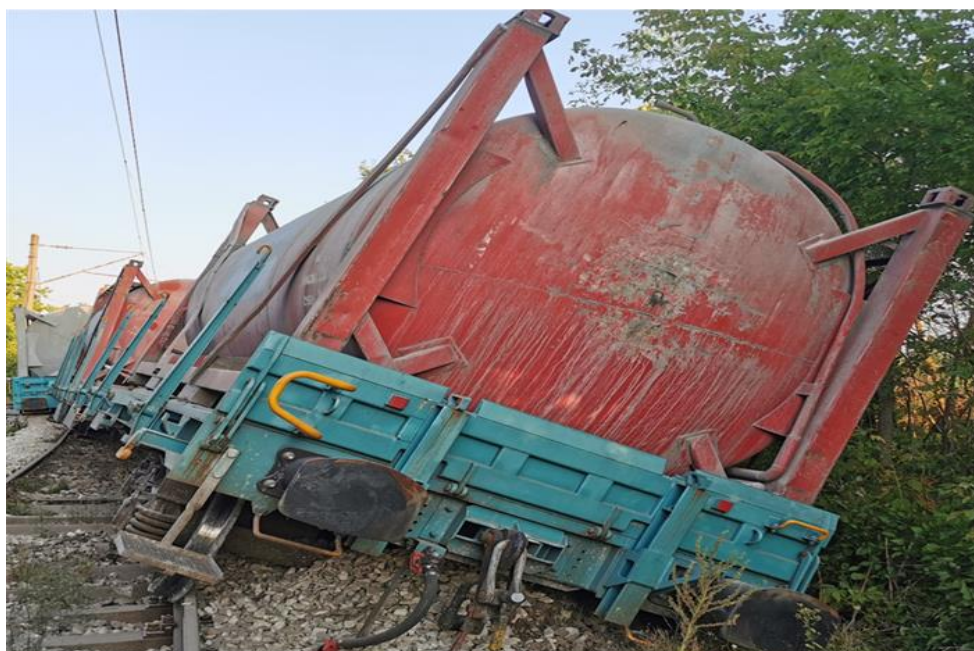
On 26.07.2022 at 12:30 p.m., DFT No. 30592 departed from Plovdiv marshalling yard, assigned by telegram/timetable of SE NRIC with a route from Plovdiv marshalling yard to Iliyantsi station at the request of the railway undertaking "Rail Cargo Carrier - Bulgaria" EOOD. The train was operated by the railway undertaking "Rail Cargo Carrier - Bulgaria" EOOD, with a route of movement Svilengrad - Plovdiv - Karlovo - Iliyantsi, consisting of 20 loaded wagons, type R and S, 80 axles, 1566 tons, with train locomotive No. 918111161116 and auxiliary locomotive at the head No. 918111162593. The two locomotives operated on a multi-unit SME system and the first locomotive carried out the control with a locomotive brigade, first-person driver and second-person driver. The train passed Stolnik station without stopping at 16:50 p.m., passed Yana station without stopping at 16:56 p.m., and at the Yana - Kremikovtsi interstation at km 19+041 at 17:01:13 p.m., five wagons of the train derailed, which caused a break in the train and it stopped at 17:01:43p.m. After the inspection by the locomotive crew, they found that the train was separated in two places (the wagons were in three parts) and five wagons at the end of the train had derailed, they informed the traffic manager on duty of Yana station and the train dispatcher of the railway line. The wagons of the train were flatbed, loaded with container/tanks full of cement.

Because of the derailment, about 100 m of railway was destroyed; the derailed wagons were also damaged.

The accident occurred because of a combination of factors. The high temperatures in the rails caused their longitudinal displacement, combined with the dynamic forces induced by the passing freight train, which resulted in the track being swept under the train in the zone of the transition from continuously welded to jointed track. The lower track resistance of derailment wooden sleepers compared to that of concrete sleepers has resulted in rail sweeps in that zone.

With recommendation 1, it is proposed that SE NRIC and "Rail Cargo Carrier - Bulgaria" EOOD familiarize the interested personnel with the contents of the report.

With recommendation 2, it is proposed that the RAEA analyse and evaluate the functioning of the Safety Management System of the SE NRIC in terms of operation, maintenance and repair of the rail track and the transitions between continuously welded and jointed rail track.

With recommendation 3, it is proposed that the SE NRIC restore the whitewashing of the continuously welded track during the summer season, in order to limit the increase in temperatures in the tracks due to solar heating.

With recommendation 4, it is proposed that SE NRIC plan and carry out repairs of the rail track at the Kremikovtsi - Yana interstation, guaranteeing traffic safety.

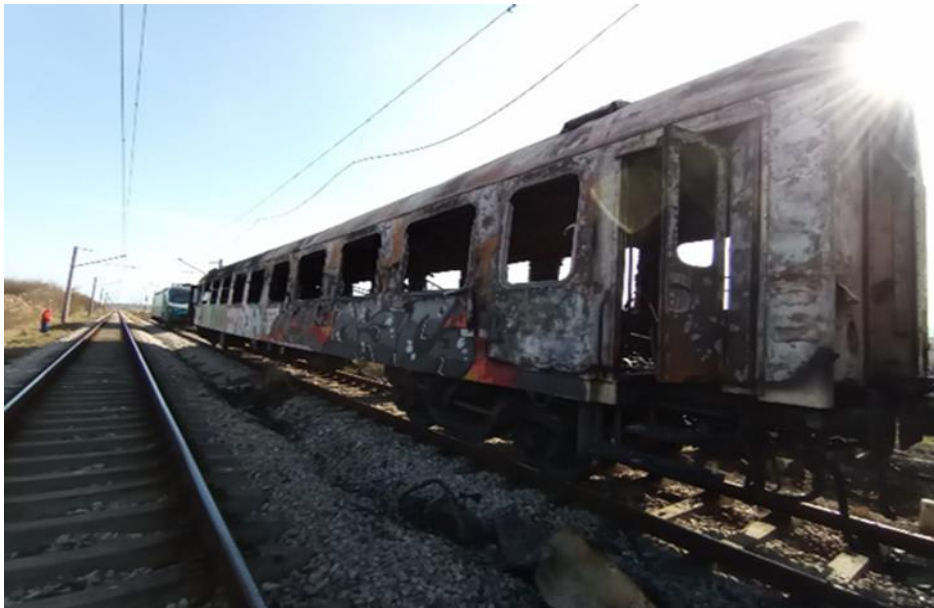
No passengers or staff were injured in the fire. Damage was caused to the catenary, and to the first two burned passenger coaches of FT No. 2613.

The accident occurred because of ignition of the power inverter of the fluorescent lighting unit in the corridor to the exit, in front of the toilet unit in the front part of the coach in the direction of train movement. The causes for that are complex, involving several factors.

With recommendation 1, it is proposed that SE NRIC and "BDZ-Passenger Services" EOOD inform the interested personnel with the content of the report.

With recommendation 2, it is proposed that BDZ PS EOOD organize talks to acquaint the repair personnel in the Wagon-repair depots of the enterprise with the circumstances and causes for the occurrence of the accident.

With recommendation 3, it is proposed that BDZ PS EOOD, when carrying out capital repairs of passenger coaches in railway plants, control the requirements for compliance with the relevant fire protection requirements for electrical installations and internal equipment, listed in Regulation (EU) No. 1302/2014 of the Commission of 18 November 2014.
