REPUBLIC OF BULGARIA
NATIONAL AIR, MARITIME AND RAILWAY TRANSPORT ACCIDENTS
INVESTIGATION BOARD

ANNUAL REPORT

NATIONAL RAILWAY TRANSPORT ACCIDENTS
INVESTIGATION BOARD

Sofia 2023

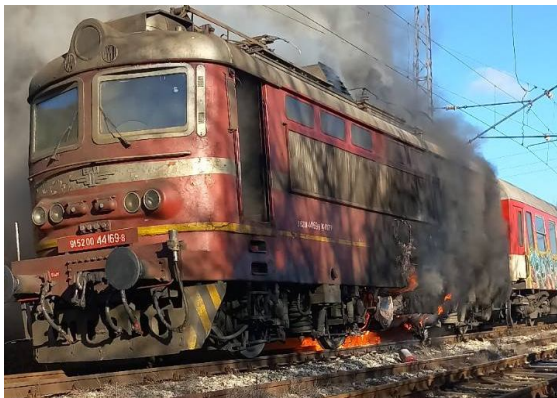
FT No. 2610 departed from Mezdra station at 10:44 a.m. The train passed on the second main track at Mezdra South Station at 10:47 a.m. without stopping, the traffic manager on duty at Mezdra South Station noticed that smoke was coming from the draft gear of the locomotive. The locomotive driver, looking to the right at the traffic manager on duty, noticed that the engine compartment was filled with black smoke and initiated a "quick stop" of the train by activating the automatic train brake. The train came to an emergency stop at 10:50 a.m., after which the locomotive quickly caught fire.

As a result of the fire, heavy material damage was caused to the locomotive. The movement of trains between Mezdra South and Zverino stations was interrupted in the period 11:00 a.m. ÷ 12:30 p.m. on 06.01.2023.

Therefore, as the immediate cause of the accident, it can be considered that the integrity of the flexible rubber joint of the first cooling circuit was broken, which led to the leakage of transformer oil. The high-temperature leaked oil exceeded the flash point, causing it to catch fire. That gave the opportunity for the fire to grow quickly and cause great material damage. Due to heavy smoke in the engine compartment, extinguishing with manual fire extinguishers was not possible by the locomotive crew.

- With recommendation 1, it is suggested that SE NRIC and "BDZ-Passenger Transport" EOOD familiarize the interested personnel with the contents of this report;
- With recommendation 2, it is suggested that BDZ PP EOOD restores the performance of monthly talks and trainings of the operating and repair personnel in the locomotive depots;
- With recommendation 3, BDZ PP EOOD is proposed to replace all elastic joints in the transformer oil cooling circuits of locomotives series 44 and 45 with metal elastic joints;
- With recommendation 4, BDZ PP EOOD is proposed to TP to carry out checks on the serviceability of the baroscopes to control the operation of the engine-pumps, as well as the condition of their starting capacitors;

- With recommendation 5, BDZ PP EOOD is proposed to design, develop and install a new PGI on the locomotive series 44 and 45;
- With recommendation 6, BDZ PP EOOD is proposed to create an organization to amend and supplement the departmental regulation PLS 100/2018 for the recovery of overhaul repairs and bring the inter-repair runs of locomotive series 43, 44 and 45;
- With recommendation 7, BDZ PP EOOD is proposed to take actions to limit the access of the locomotive crew to the devices and electrical hard connections for control in device cabinets M1 and M2 in the first and second cabins of locomotives series 44 and 45;
- With recommendation 8, BDZ PP EOOD is proposed to install video recorders on the two front walls of the locomotives with visibility to the railway infrastructure and in the two command cabins of the locomotives.

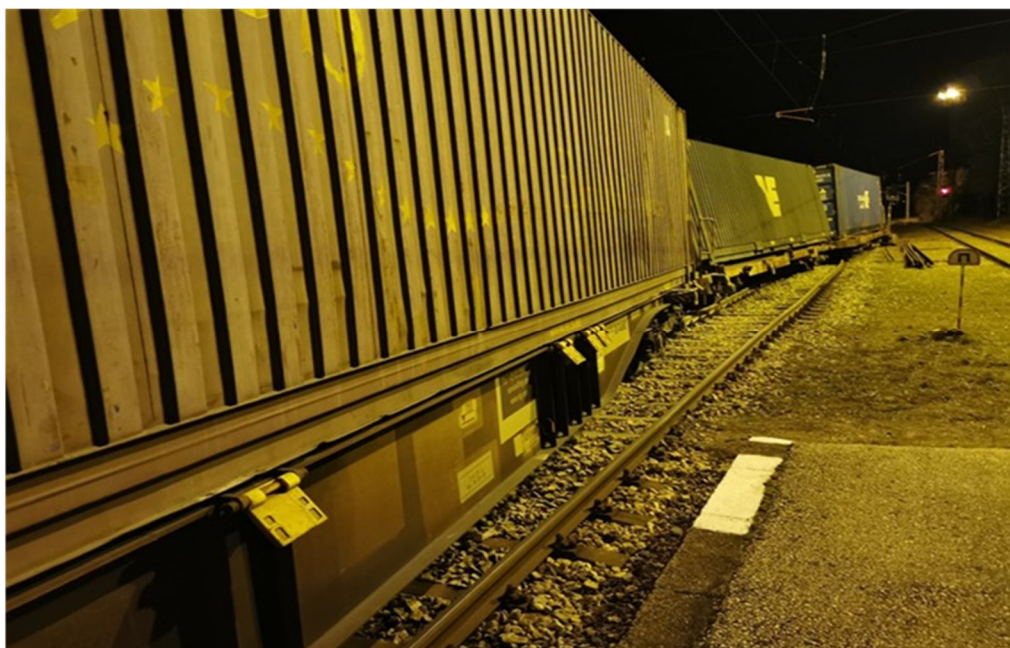
For accepting IDFT No. 40832 at Banya station at 00:30 a.m. on 26.02.2023, the traffic manager on duty ordered a route for the train to cross the second main track without stopping at the station. When the train entered Banya station, the traffic manager on duty noticed sparks coming from the wheels of the last wagons and the train stopped. The locomotive crew felt the train pull and noticed that the pressure in the main air duct dropped to 0.0 bar and the train stopped on the second track at 00:41 a.m. The locomotive driver and duty conductor inspected the train and found that there have derailed the last two wagons of the train, 16th no 37804953012-4 series Sggmrs has derailed with both wheelsets of the third bogie and 17th wagon no. 43714378583-4 series Saagrss has derailed with all four wheelsets of the wagon.

Wagon No. 43714378583-4 was repaired - the replacement of a leaf spring set. On 25.02.2023, the wagon was included in the composition of IDFT No. 40832. After the replacement of the spring, inadmissible differences in the weight distribution on the left/right wheel of the first and second wheelset appeared, since the spring has different geometric parameters and characteristics from the original one. The technical staff did not detect the difference. During the static measurement after the derailment, an inadmissible "oblique-symmetric load" was found (between the first two wheelsets of the wagon). The large weight difference between the wheels in the left curve of the rail track caused the right wheel of the second wheelset to rise on the head of the right rail and for 14 m it derailed to the right.

The immediate cause of the accident was the installation of an inappropriate leaf spring on the derailed wagon No. 43714378583-4, which led to the appearance of inadmissible differences in the load on the first two wheelsets (left/right wheels) of the wagon. An aggravating circumstance is that this wagon was loaded with GTK of greater weight.

- With recommendation 1, it is suggested that SE NRIC and "DB Cargo Bulgaria" EOOD familiarize the interested personnel with the content of this report.
- With recommendation 2, it is suggested that "DB Cargo Bulgaria" EOOD, when accepting rolling stock at the border stations, which will be served by the railway company, to increase the quality and control when performing the technical inspections.
- With recommendation 3, it is proposed that the SE NRIC build a control point (Check Point) between the Kapikule and Svilengrad border stations with the following functionalities:
 - o Measurement of the vertical load on the left/right wheel of the wheelsets in motion of the road transport vehicle;
 - o Deviations from the shape of the wheels (trenched and layered tires) of the road transport vehicle;
 - o Dimensional frame.

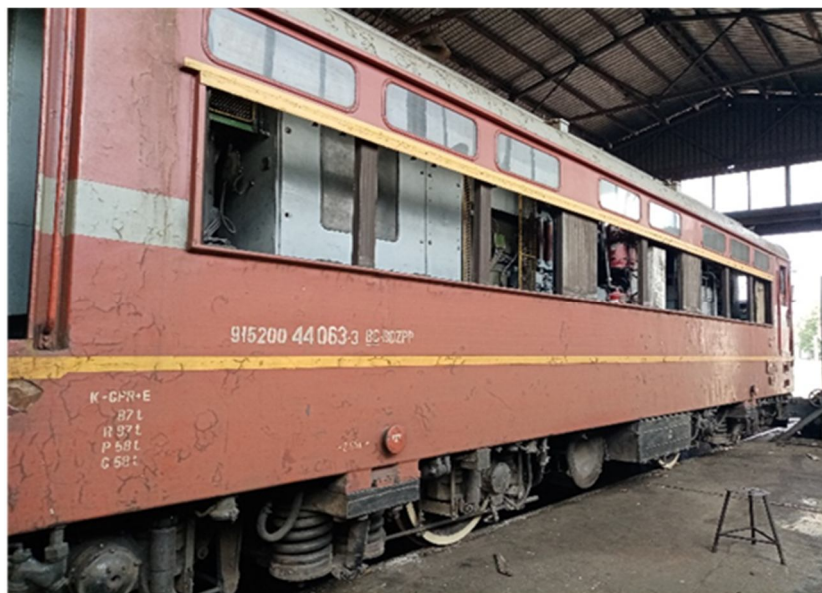
Because of the fire, material damage was caused to the burnt locomotive No. 91520044063-3, which served train No. 80132. No personnel or passengers were injured. The movement of trains between Bezmer - Yambol - Zavoy stations was not interrupted.

The accident was caused by damage to the compressor and an increase in temperature during operation in the area of the power unit of the compressor.

- With recommendation 1, it is suggested that SE NRIC and "BDZ-Passenger Transport" EOOD familiarize the interested personnel with the contents of this report;
- With recommendation 2, BDZ PP EOOD is proposed to carry out an analysis of the damage that occurred that led to accidents and the subsequent repairs as necessary;
- With recommendation 3, BDZ PP EOOD is proposed to carry out a comprehensive change of the regulations for the repair and maintenance of the electric locomotives series 43, 44 and 45, which have not been overhauled (PDR-LS 0103/1978 and PZR - PLS 127/2005);

- With recommendation 4, BDZ PP EOOD is proposed to conduct periodic trainings to increase the professional qualification of the engineering and technical personnel engaged in the repair and maintenance of locomotives;

- With recommendation 5, it is suggested that BDZ PP EOOD assigns to the locomotive depots every locomotive entered for TP, the engine compartment to be cleaned regularly with a vacuum cleaner, and the large aggregates to be dismantled and thoroughly cleaned at each MPR;

- With recommendation 6, it is suggested that BDZ PP EOOD equip the locomotive depots with infrared cameras to detect the places with increased temperature after prolonged operation of the locomotive.

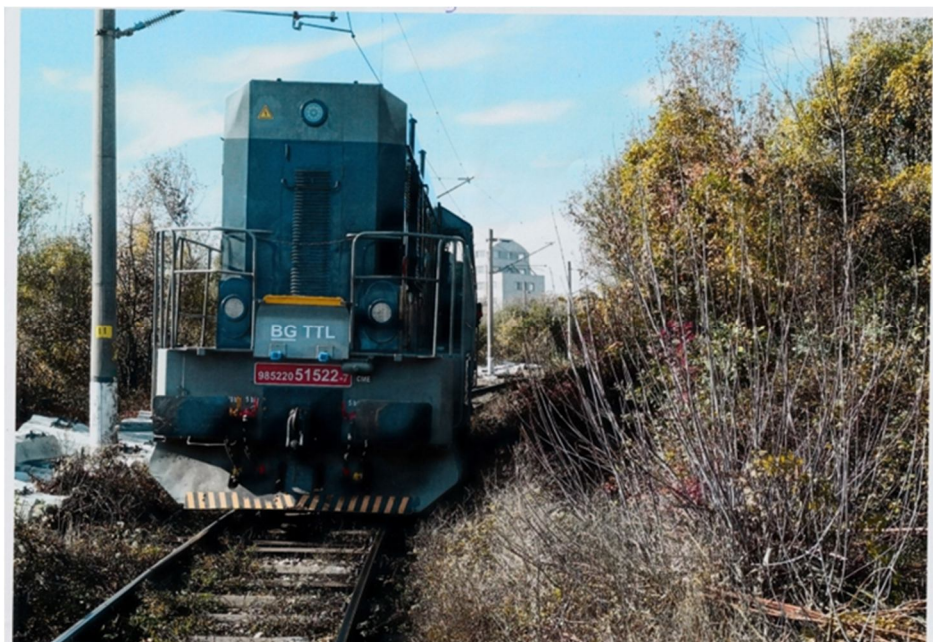
Consequences of the event was the running over of two workers during work on the railway. The third worker, who saw the two being run over, walked towards the locomotive and the locomotive driver stopped the locomotive. The locomotive driver then came to know that he had run over two persons and both of them took follow-up action by notifying the concerned departments and officials.

The accident occurred because of non-compliance with the requirements of the normative acts, which ensure safety at work in the workplace. There were no signalmen guarding the work group, and no warning signs have been placed surrounding the workplace. The locomotive was operated with only a locomotive driver without an assistant locomotive driver. After the locomotive left the station, it entered a left curve on the rail track with a radius $R=250$ meters. The locomotive driver was operating the locomotive from the right console, which limited his forward visibility, and he did not see the two workers working in the interstation.

- With recommendation 1, it is suggested that SE NRIC and CTVB JSC inform the interested staff with the contents of this report;

- With recommendation 2, it is suggested to the SE NRIC that the authorities for safety and health at work undertake systematic inspections regarding the quality of the types of briefings conducted (including daily ones) by the direct supervisors and the entries in the briefing books;

- With recommendation 3, it is suggested to the SE NRIC that the occupational safety and health authorities organize and conduct trainings for the direct supervisors conducting the types of personnel briefings in the railway sections, paying attention to the risk assessment and accompanying hazards in the types of works on the rail track;

- With recommendation 4, it is suggested that SE NRIC systematically conduct trainings for personnel working with mechanized equipment and machines, for which legal capacity is required;

- With recommendation 5, CTVB JSC is proposed to supplement the texts regarding safety and control over the implementation of the provisions in the "Instructions for the work of locomotive drivers and assistant drivers when performing train and shunting activities" and in "Management of "Movement" of "Cargo Trans Vagon Bulgaria" JSC, part of the Safety Management System;

- With recommendation 6, CTVB JSC is proposed to correct and supplement the texts in the book for daily instruction regarding the safety of the movement of shunting trains in the interstation SP 4 - Iliyantsi

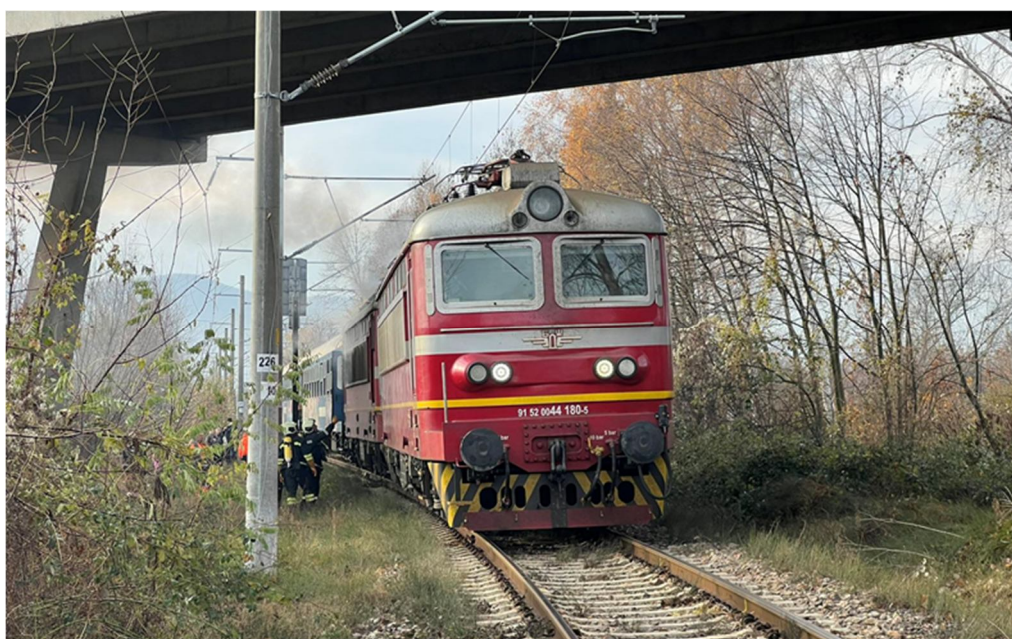
07:46 a.m. at km 226+900 and attempted to turn on the MAD, but without success. Through the window of the engine compartment, he saw that there was thick smoke inside. Sprayed a fire extinguisher, but failed to put out the fire. Activated the fire system from the first cabin, but it did not activate, then proceeded to the second command cabin, but it was inaccessible due to the thick smoke coming from the engine compartment.

At 08:25 a.m., the locomotive driver informed the traffic manager on duty at the Tulovo station that the locomotive had caught fire and asked help to remove the train. The head of the Tulovo station called the national emergency number 112 and informed about the fire.

No passengers or staff were injured; material damage was done to the locomotive. There is no material damage to the railway infrastructure.

Because of the fire, heavy material damage was caused to the locomotive.

The most likely cause of the fire during movement in locomotive No. 91520044202-7, which served IFT No. 464, was the temperature overheating of the power unit 221, feeding the motor-compressor 235. The auxiliary rectifier 221, feeding the compressor motor, was not cooled at that time as the fans were switched off when the train was moving on inertia.

- With recommendation 1, it is proposed that SE NRIC and "BDZ-Passenger Transport" EOOD familiarize the interested personnel with the contents of this report;

- With recommendation 2, BDZ PP EOOD is proposed to undertake the replacement of capacitors with electrolyte of the R-C groups with dry type capacitors of locomotive series 44 and 45;

- With recommendation 3, BDZ PP EOOD is proposed to install technical means (thermostats) for temperature control of rectifier groups 020 and 022 of locomotive series 44 and 45;

- With recommendation 4, it is proposed that BDZ PP EOOD restore the power supply to the electronic unit for controlling the auxiliary machines Y2 from the own transformer 222, in accordance with the design schemes of the manufacturing plant for series 44 and 45;

- With recommendation 5, BDZ PP EOOD is proposed to organize and carry out renovation (overhaul) of the locomotives of series 44 and 45, which are due for overhaul.
