**REPUBLIC OF BULGARIA**  
**NATIONAL AIR, MARITIME AND RAILWAY TRANSPORT, ACCIDENTS**  
**INVESTIGATION BOARD (NAMRTAIB)**

**FINAL REPORT**

**Investigation of railway accident – derailment of IDFT № 46660 between the stations Lyubenovo  
transmission station – Radnevo on 03.02.2024**

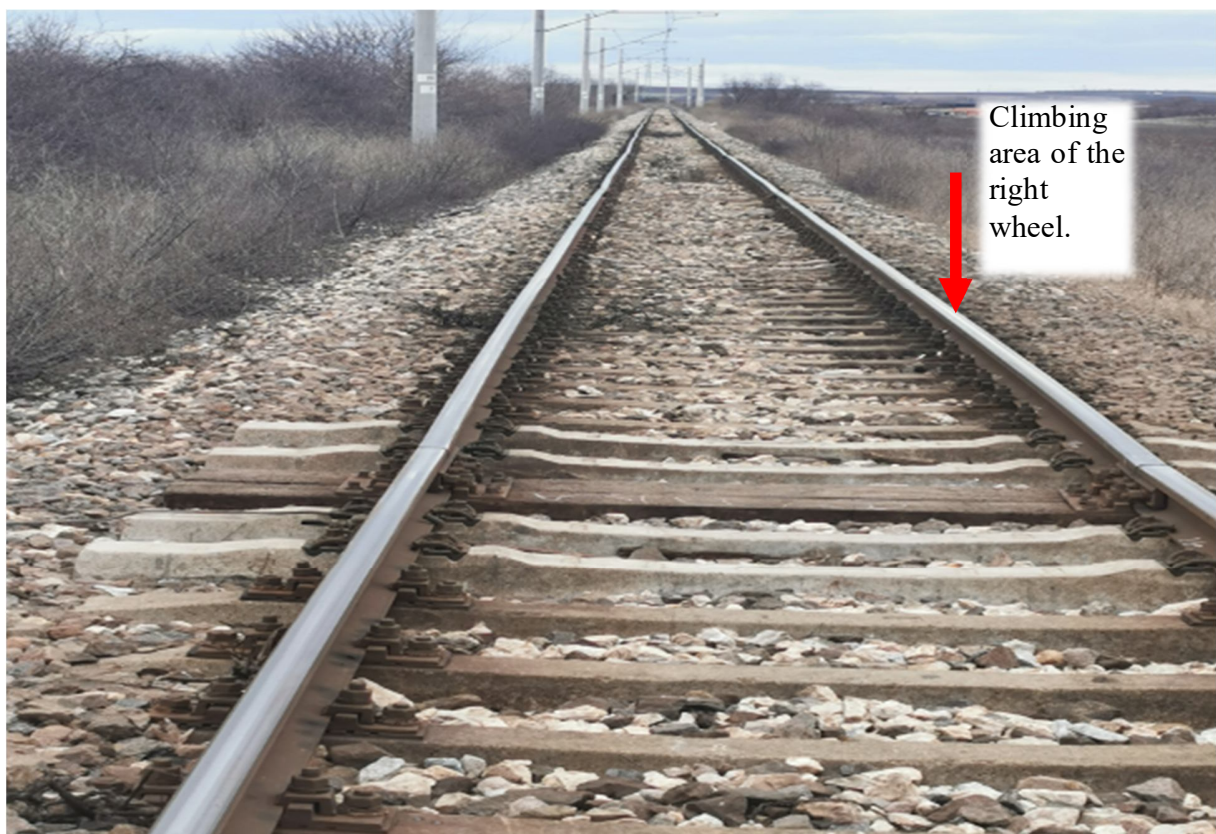
**Fig. 1.2. The area of derailment of wagon № 21802475039-8 of IDFT № 46660**

The event occurred between the Lyubenovo transmission stations - Radnevo station at km 28+197 in a transitional curve at 10:28 a.m. on 03/02/2024. The derailment zone of the wagons is in a right curve with length  $L=98$  m, radius  $R=400$  m, super elevation  $H=90$  mm and profile  $=0$  ‰. The rail track is laid with rails type S49 – 25 meters, reinforced concrete sleepers mixed type ST-4 and ST-6, fasteners mixed type PAK-68I and SKL-14 (fig. 1.1 and 1.2.).

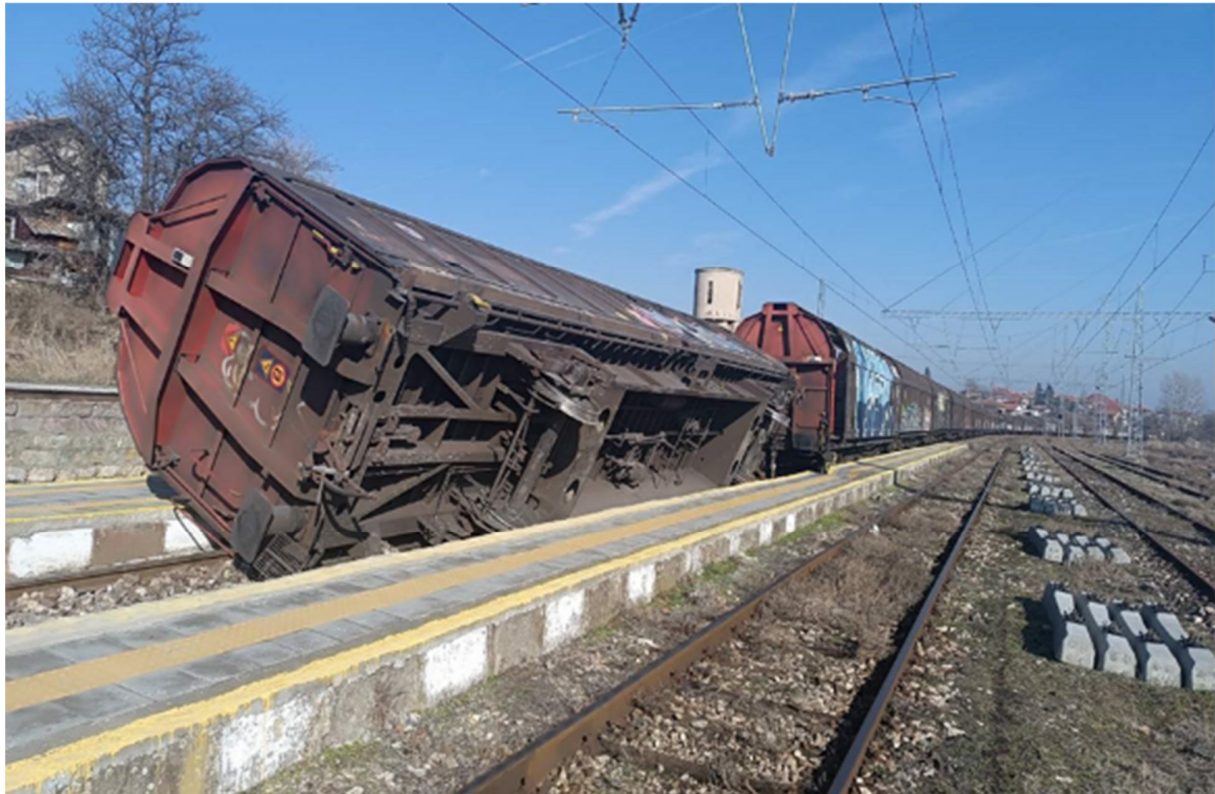
**Fig. 2.1. Derailed two last wagons of IDFT № 46660**

The last wagon No. 21802475230-3 was caught by the first derailed and it derailed with both wheel-sets while passing through the entrance switches and the technical canal of the second track and tilted to the left on the platform of the track, at which time the locomotive driver felt the pull of the train and initiated braking (Fig. 2.1).

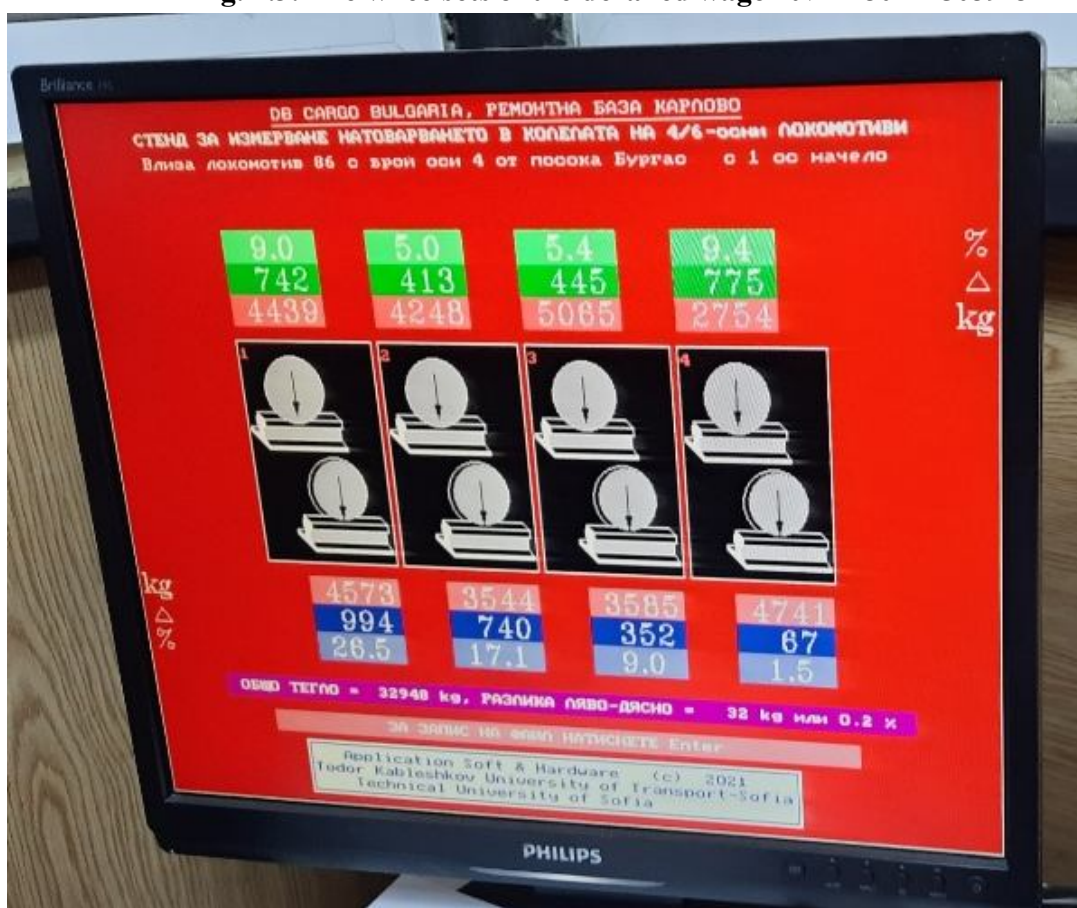
**Fig. 2.4. The measuring results of the static loading of the wheelsets of the derailed 31-st wagon № 21802475039-8 on 19.02.2024.**

The Commission accepted the results of the measurement for information and they could not serve as an evidence for the state of the static load of the wagons, due to the specifics of the electronic scale, which was designed for measuring four-axle locomotives (Fig. 2.4).

Differences in the loading of the wheels and wheelsets were found, which, because of the derailment, led to severe deformations and damage to the draft gears, as well as the missing two side doors on the left side of the wagon in the direction of the train's movement (Fig. 2.4).

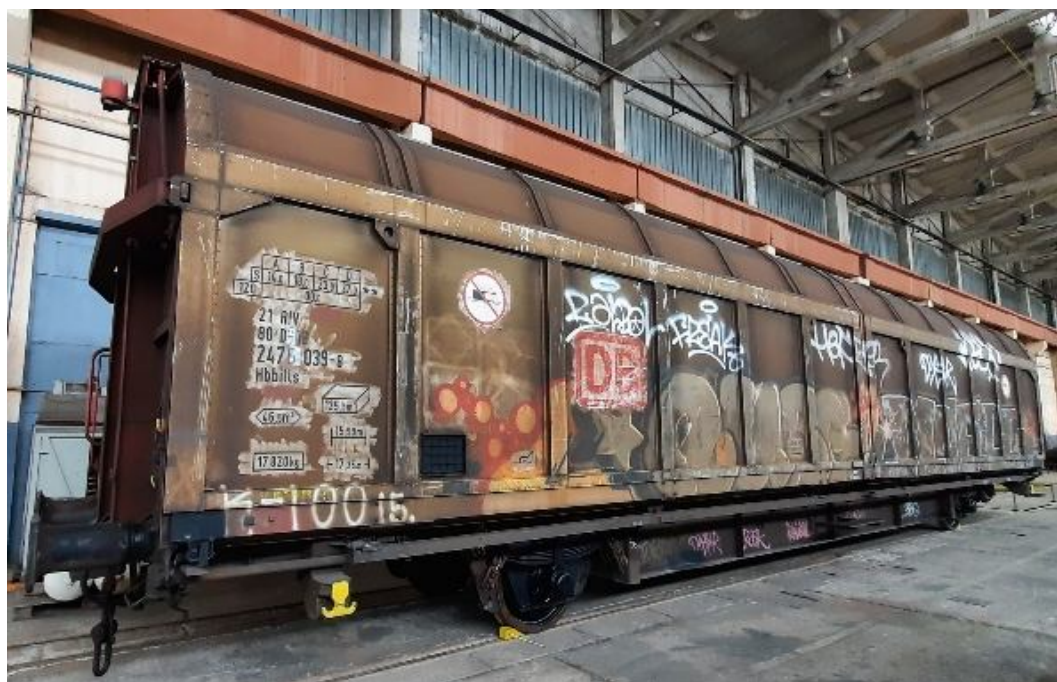
**Fig. 2.5. Wagon № 21802475039-8 in RBCO Karlovo after the performed repair of the draft gear**

On 09 and 10.05.2024, in the presence of the Investigation Commission in RBCO-Karlovo, after the recovery of the derailed 31st wagon No. 21802475039-8, new control static weight measurements of the electronic scale on wheels and axles were carried out for the purpose of establishing and comparing of the differences in the static load of the wheels, for which a protocol was drawn up with the reported control results (fig. 2.5, 2.6, 2.7).

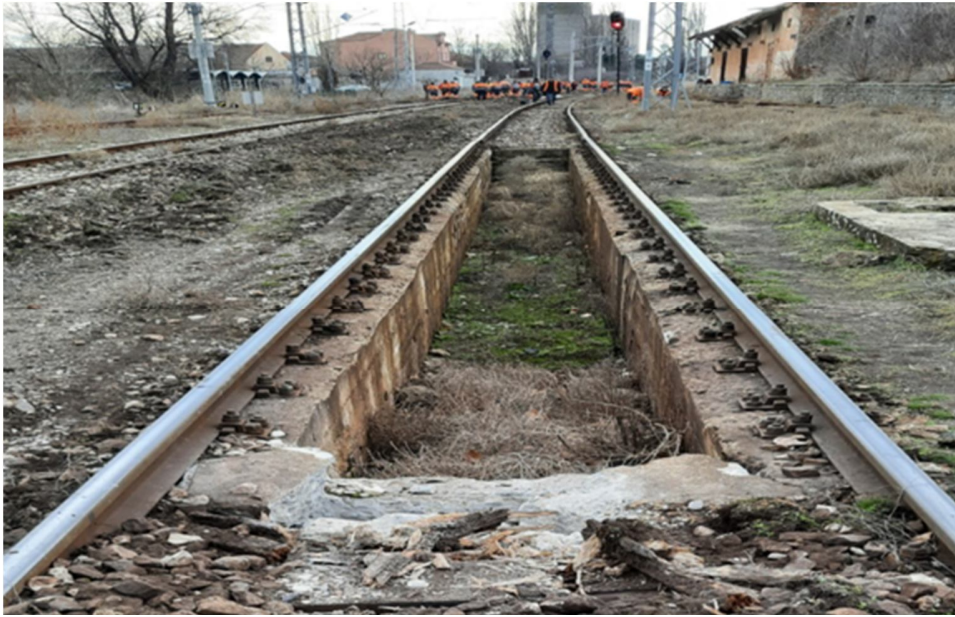
**Fig. 3.6. Technological canal on second track in Radnevo station**

In Radnevo station the entrance and exit semaphores are under the speed signalling – functioning before the accident and with caused damages of the exit semaphore for the second track after the accident – technological canal of the track (fig. 3.6);

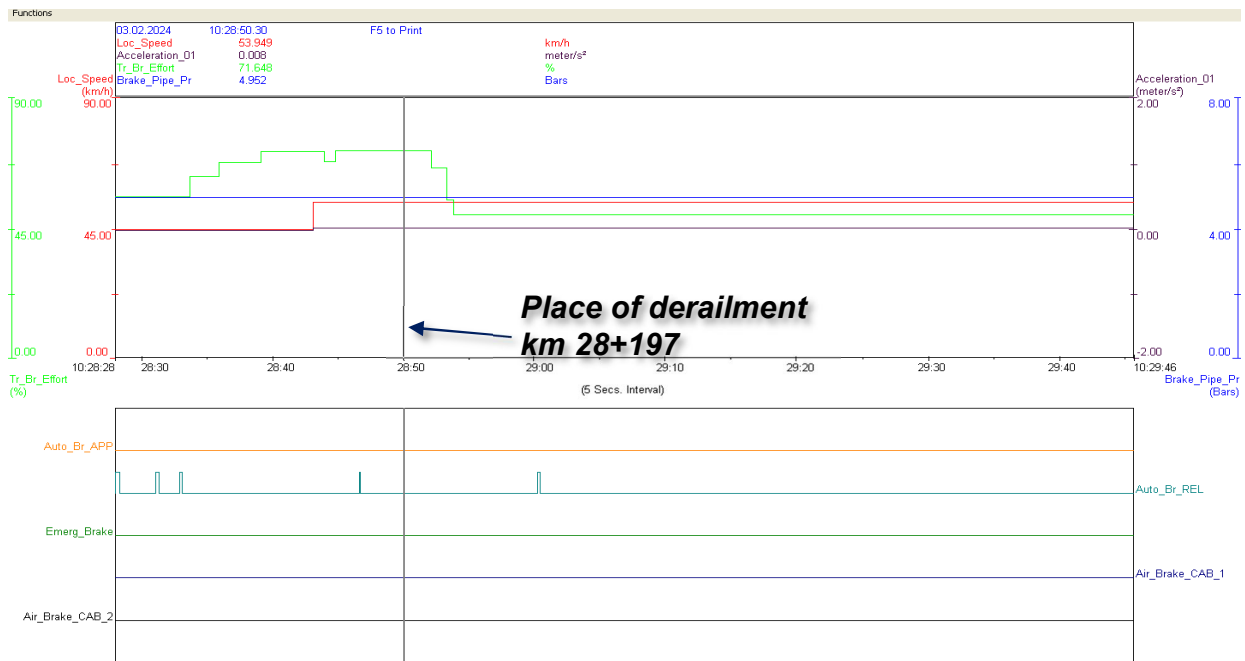
Fig. 4.4.

that point, the speed decreased to 45.51 km/h and the movement at that speed continued until 10:28:41 a.m. and increased to 53.95 km/h. In the interval of the train's movement, the second wheelset of the penultimate 31st wagon of the train's composition derailed (fig. 4.3, item 1). From the graphs in Fig. 4.3 and fig. 4.4 it can be seen that at the time of the train derailment, it was already moving in traction mode at a speed of 53.95 km/h, without shocks after increasing the speed for about 150 meters, before the moment when the rear right wheel went up on the head of the right rail of the 31st wagon of the train composition.

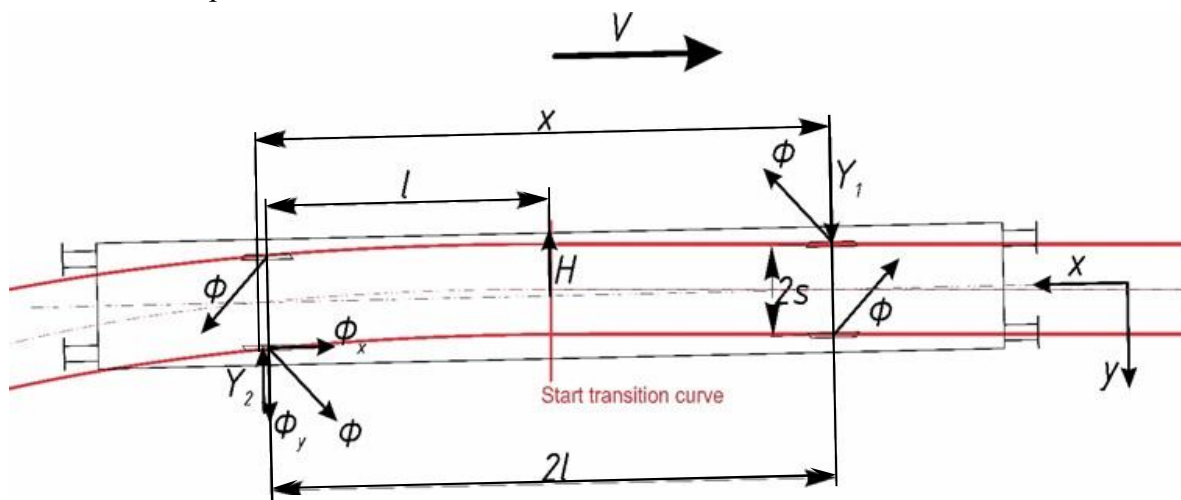
Fig. 4.17.

From the calculations made and from figure 4.17, it is clear that at the moment of ascent, the second wheelset touches the right rail, as a result of which the transverse guiding force  $Y_2$ , arising in the right wheel of the second wheelset in the direction of movement, is directed inward to the gauge, i.e. there is maximum crossing type wagon positioning. At the same time, the frictional force  $\Phi_y$  at the same point is directed outward from the gauge and has a greater value than the guiding force  $Y_2$ . All this causes a shift of the rear part of the wagon (its second wheelset) towards the center of the transition curve, i.e. inward (to the right) in the curve. The situation is combined with the galloping of the wagon, caused both by the rail track (whose parameters are within the thresholds set by the normative documents), and by the spring suspension (also within the thresholds set by the norms) and the small mass of the wagon (empty).
