AIR, MARITIME AND RAILWAY ACCIDENT
INVESTIGATION NATIONAL BOARD
9, Dyakon Ignatiy Street, 1000 Sofia, Bulgaria

Ref.:
AAIU-2022-04

SERIOUS INCIDENT, OCCURRED ON NOVEMBER 17, 2022, INVOLVING A319-111 AIRCRAFT, REGISTRATION MARKS G-EZBV, OPERATED BY „EASYJET“, RELATED TO THE LACK OF PRESSURISATION DURING CLIMB

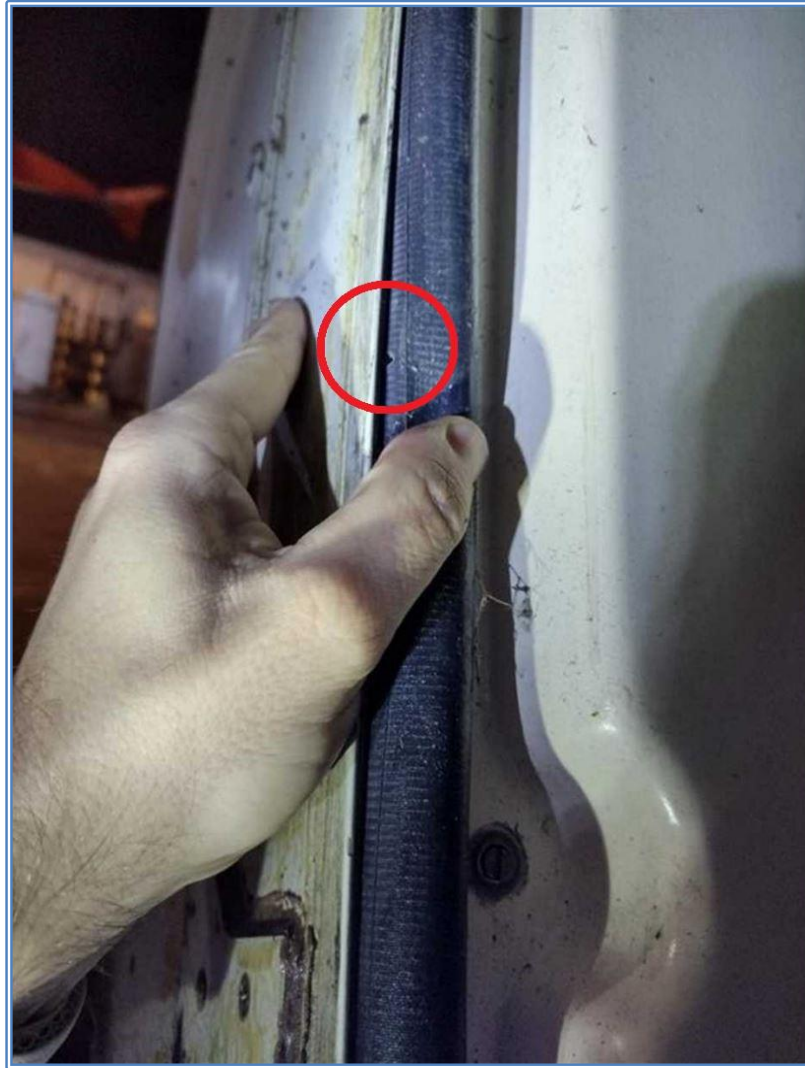
Fig.1

Disruption of the technological process of the installation of the aft cargo door pressure seal during the base maintenance activities by the maintenance crew of Lufthansa Technik Sofia, which resulted in a significant cabin leakage.

During the inspection carried out after the completion of the flight it was found that the Aft cargo door seal was incorrectly installed. From the photograph below the inflation holes are oriented towards the outer side of the aircraft and not towards the inner side.

15. During the inspection carried out after the flight it was found that the Aft cargo door seal was incorrectly installed (the inflation holes are oriented towards the outer side of the aircraft and not towards the inner side).

BG.SIA-2024-01. Lufthansa Technik Sofia to include the doors inflatable pressure seals replacement on A320 Family aircraft in the Critical Maintenance Task as separate entry with the check for correct orientation of the inflation holes to be the subject of Independent Inspection.

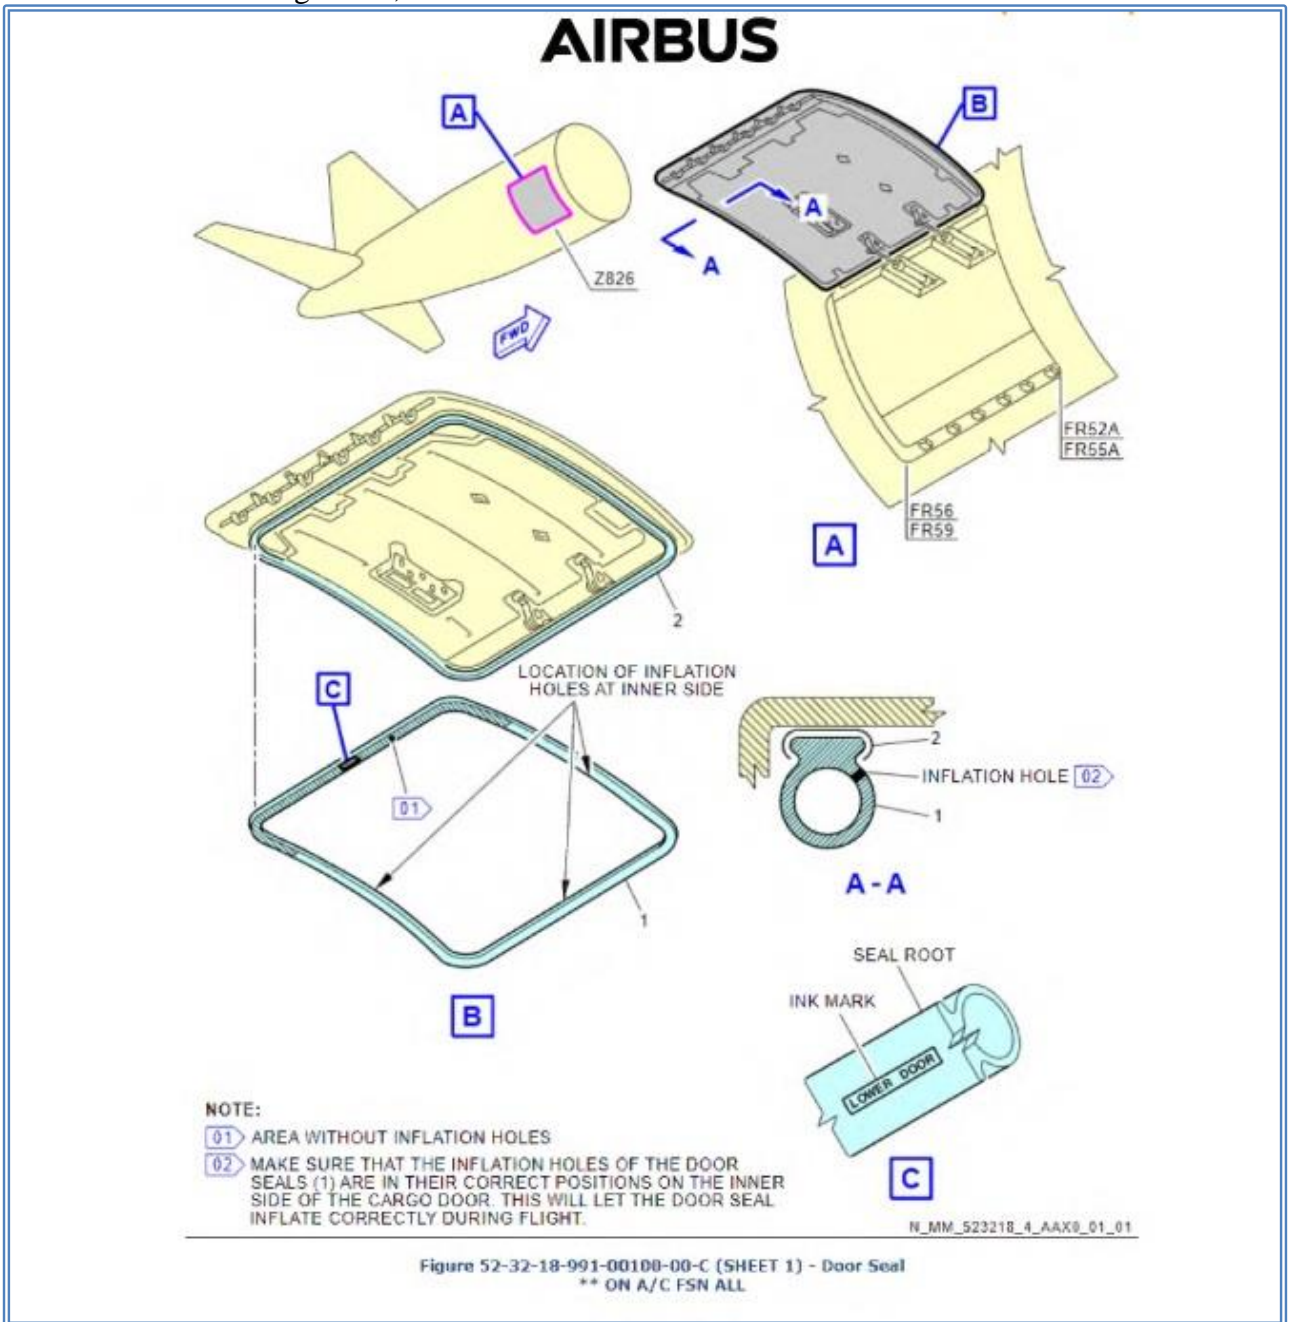
Fig.6

The AMM figure below (reference 52-32-18-991-00100-00-C) illustrates the installation of the cargo door seal on the aft cargo door, and the correct location of the inflation holes on the inner side.

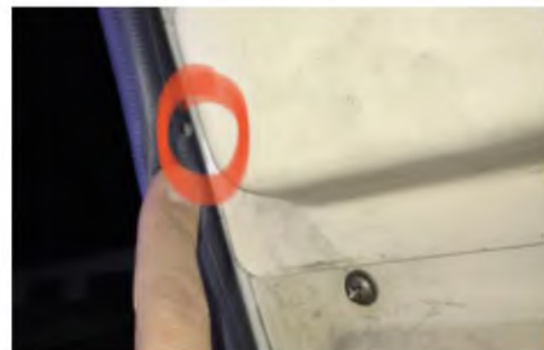
The seal surrounds the whole door inside the seal retainer of the structure. When correctly installed, the inflation holes face the inner side of the cargo door.

**Correct installation:
Inflation hole facing the inner side of the door**

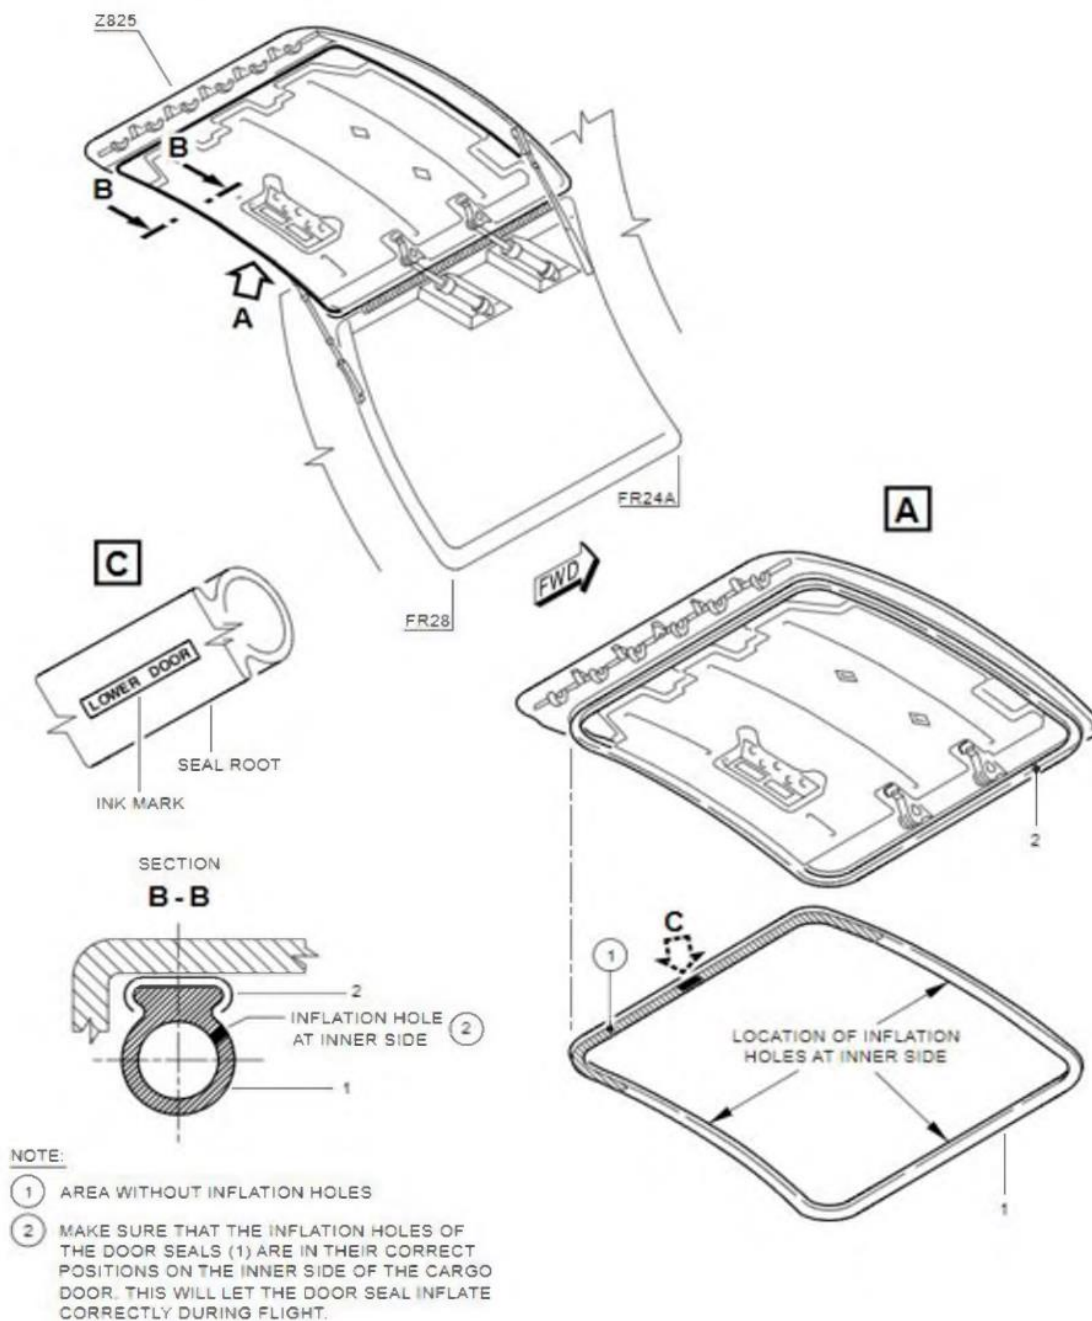
A320 fwd cargo door seal installation

- A visual inspection of the door seal is required after installation to make sure that it is compressed along its length and that the inflation holes of the door seal (1) are in their correct position on the inner side of the cargo door.

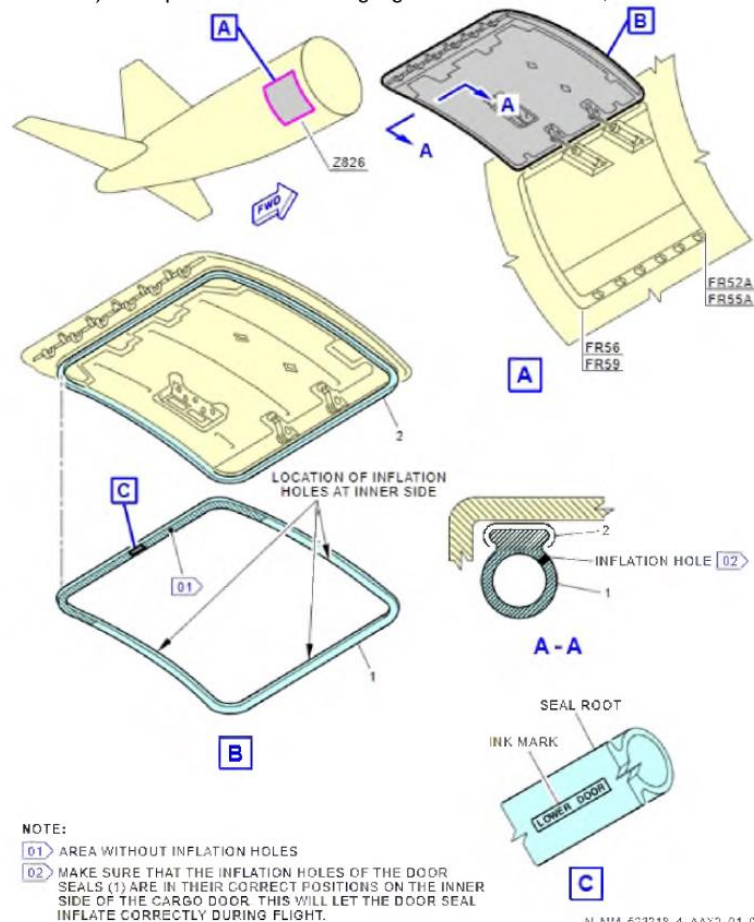
Figure 1: Aft Cargo Door Seal Installation (extract from AMM Figure 52-32-18)

During replacement, the cargo door seal must be installed in the correct position, with the inflation holes facing the inner side of the fuselage. In case of the wrong orientation of the seal holes, the seal will not serve its purpose and cause the inability to pressurize the cabin or lead to cabin depressurization.

AMM tasks Ref.3 provide all necessary instructions for correct installation of the cargo door seals (see Figure 1 for illustration). Best practices are also highlighted in articles Ref.1, Ref.4 and Ref.5.
