**REPUBLIC OF BULGARIA**  
**NATIONAL AIR, MARITIME AND RAILWAY TRANSPORT, ACCIDENTS**  
**INVESTIGATION BOARD (NAMRTAIB)**

**FINAL REPORT**

**Investigation of railway accident – derailment of IDFT № 46660 between the stations Lyubenovo  
transmission station – Radnevo on 03.02.2024**

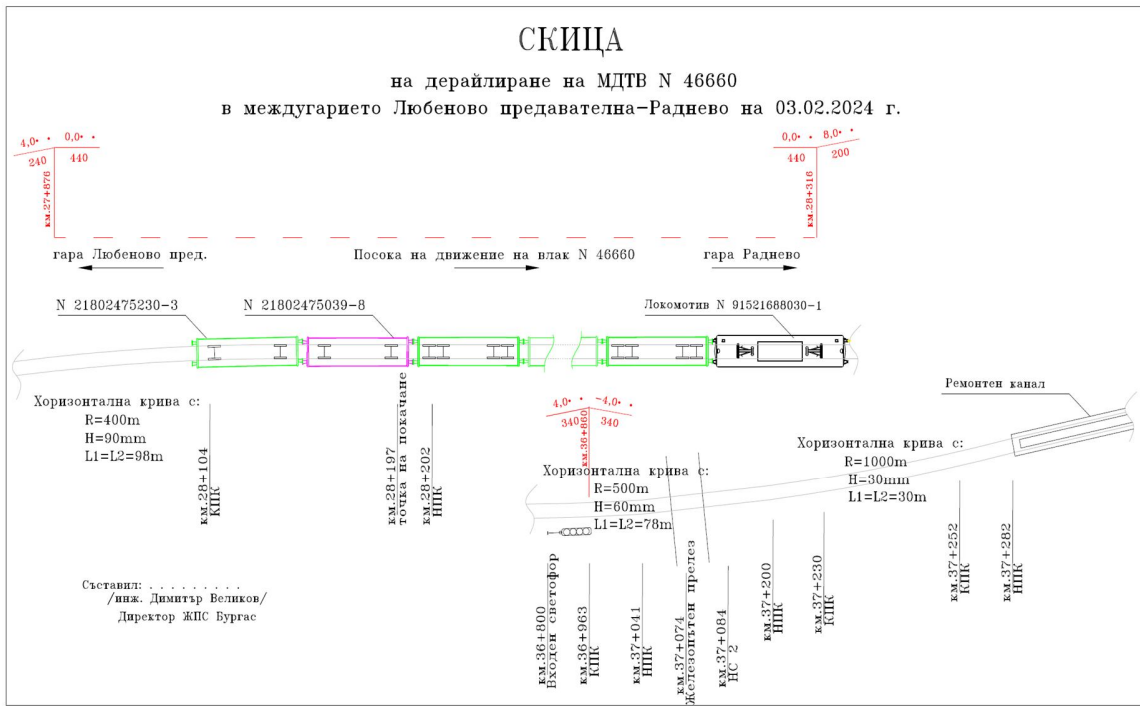
**Fig. 1.1. Scheme of the derailment location of IDFT № 46660**

The event occurred between the Lyubenovo transmission stations - Radnevo station at km 28+197 in a transitional curve at 10:28 a.m. on 03/02/2024. The derailment zone of the wagons is in a right curve with length  $L=98$  m, radius  $R=400$  m, super elevation  $H=90$  mm and profile  $=0$  ‰. The rail track is laid with rails type S49 – 25 meters, reinforced concrete sleepers mixed type ST-4 and ST-6, fasteners mixed type PAK-68I and SKL-14 (fig. 1.1 and 1.2.).

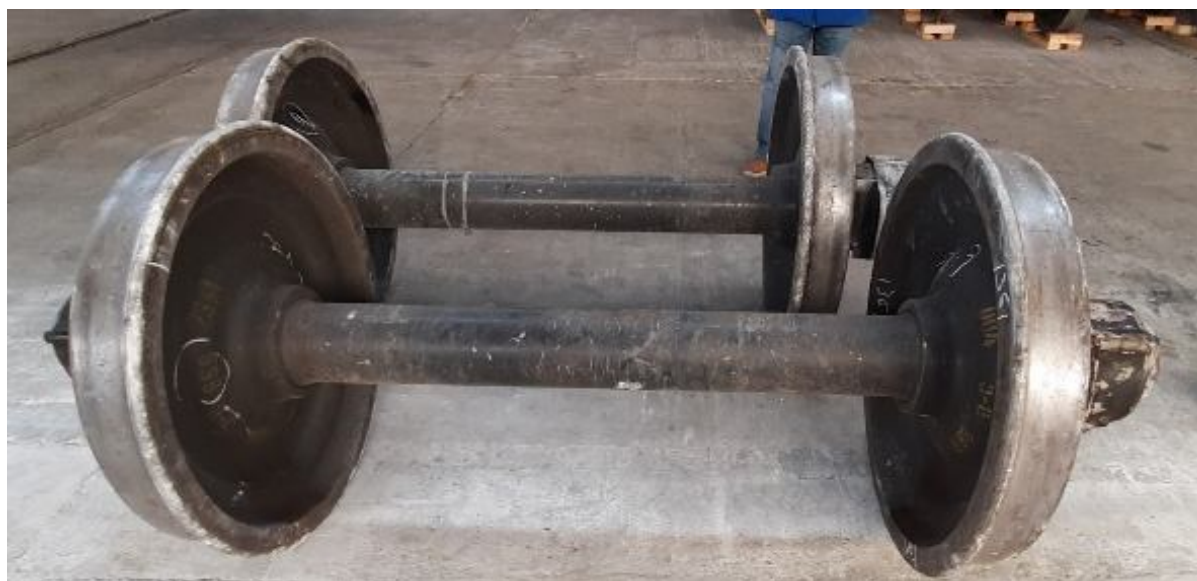
**Fig. 2.3. The wheelsets of the derailed wagon № 21802475039-8**

On 05.02.2024, at Radnevo station, the Task Force, in the presence of employees of the two entities, measured the parameters of the wheelsets of the two derailed wagons No. 21802475039-8 and No. 21802475230-3. The measured parameters of the wheelsets of the first derailed wagon No. 21802475039-8 in the interstation were within normal limits. All the sides of the wagon were badly dented and the draft gear was damaged. Movement of the wagon in that condition was impossible. That necessitated replacing the wheelsets in place with reversible wheelsets. During derailing, the four wheelsets boxes were "rotated", and in order to measure the other parameters of the wagon boxes, must have been placed under the springs.

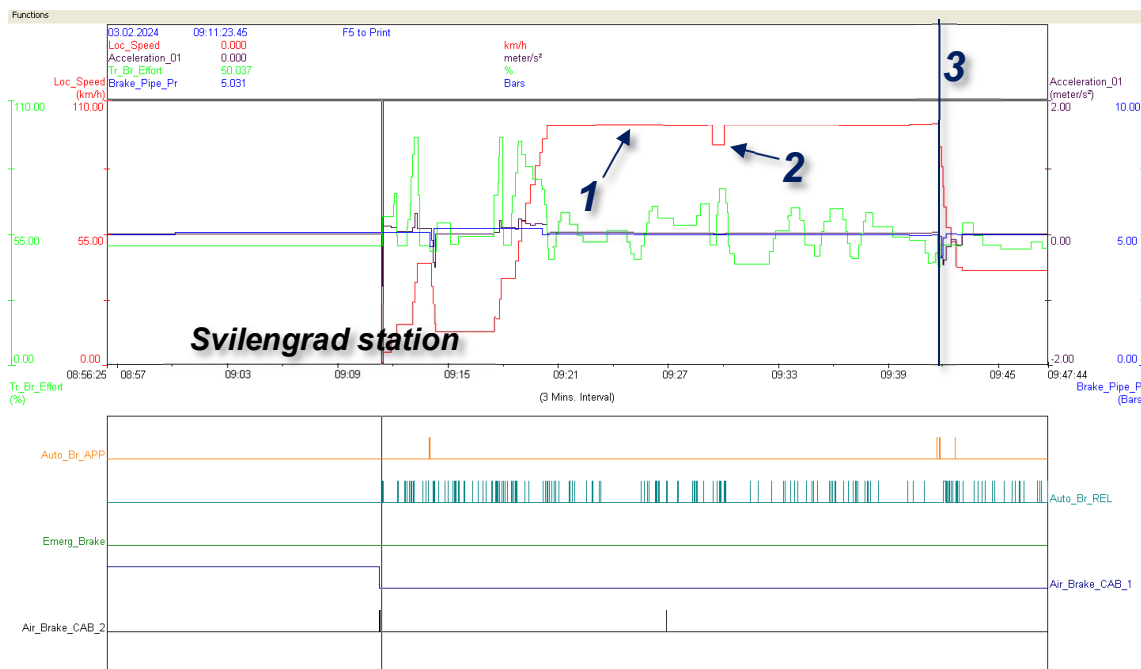
**Fig. 4.1.**

The train departed from Svilengrad station at 09:11 and ran without stopping to Radnevo station. After departure, the speed reached 99-100 km/h (Fig. 4.1, item 1). From 09:29:28 a.m. to 09:30:10 a.m., the speed decreased to 91.5 km/h without using the automatic train brake, after which it was again restored to 99.9 km/h (Fig. 4.1, pos. 2).

At 09:41:47 a.m. at km 2319.994 (on the locomotive odometer) the locomotive driver activated the automatic train brake, reducing the pressure in the main air duct from 4.916 to 4.059 bar (Fig. 4.1, item 3). Shortly thereafter, pressure in the main air duct was restored. The speed decreased from 100 km/h at 09:41:47 a.m. to 39 km/h at 09:43:02 a.m. The train traveled 2,065 m. At 09:48:33 a. m. the speed was increased to 54,674 km/h and so it traveled 6,487 m in 7 minutes 04 seconds.

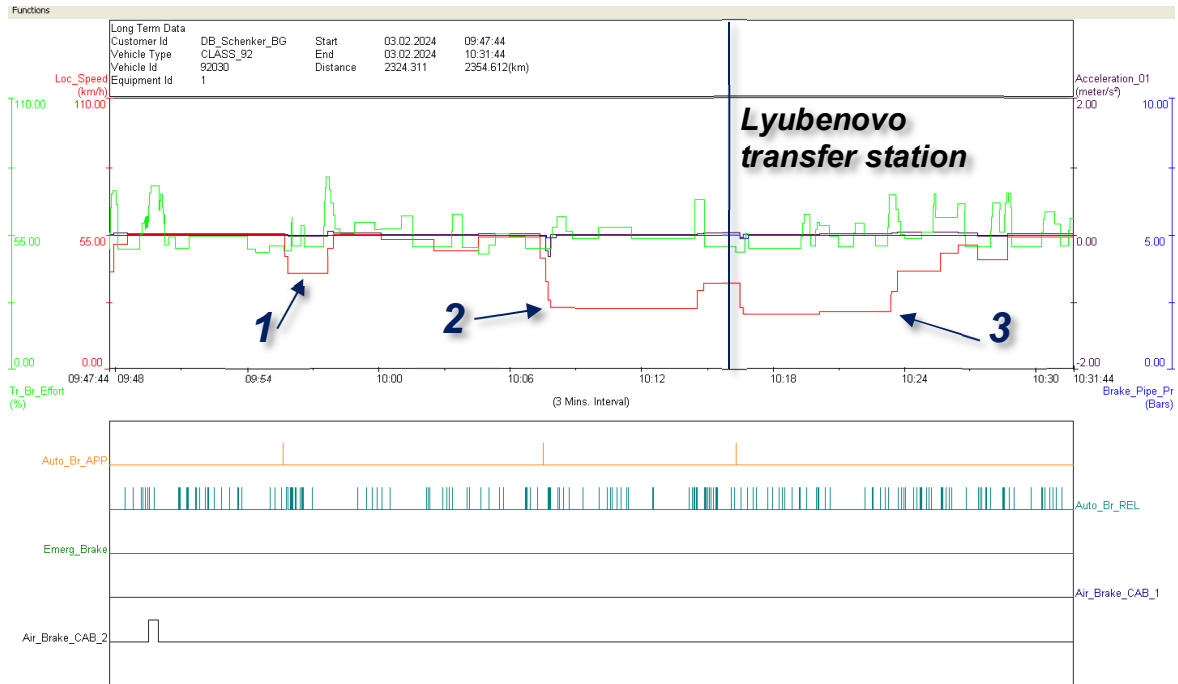
**Fig. 4.2.**

At 09:55 a.m. the speed started to decrease to 38,76 km/h without using the automatic train brake as it continued until 09:57:57 a.m. (fig. 4.2, pos. 1).

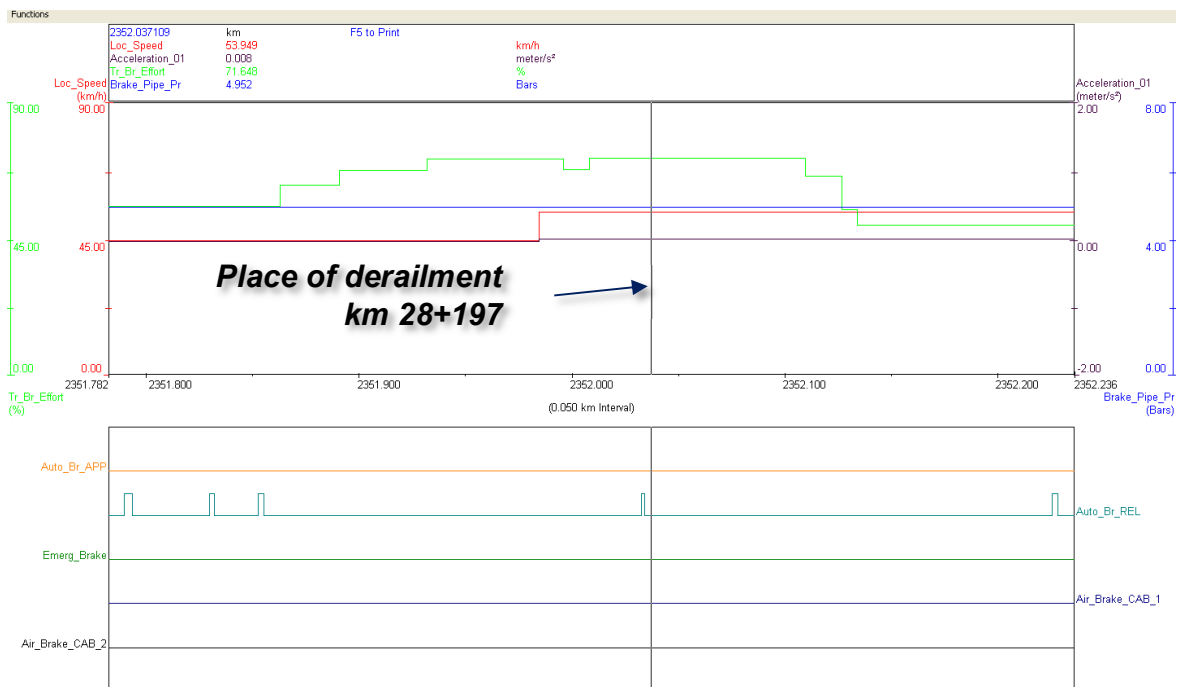
**Fig. 4.3.**

that point, the speed decreased to 45.51 km/h and the movement at that speed continued until 10:28:41 a.m. and increased to 53.95 km/h. In the interval of the train's movement, the second wheelset of the penultimate 31st wagon of the train's composition derailed (fig. 4.3, item 1). From the graphs in Fig. 4.3 and fig. 4.4 it can be seen that at the time of the train derailment, it was already moving in traction mode at a speed of 53.95 km/h, without shocks after increasing the speed for about 150 meters, before the moment when the rear right wheel went up on the head of the right rail of the 31st wagon of the train composition.

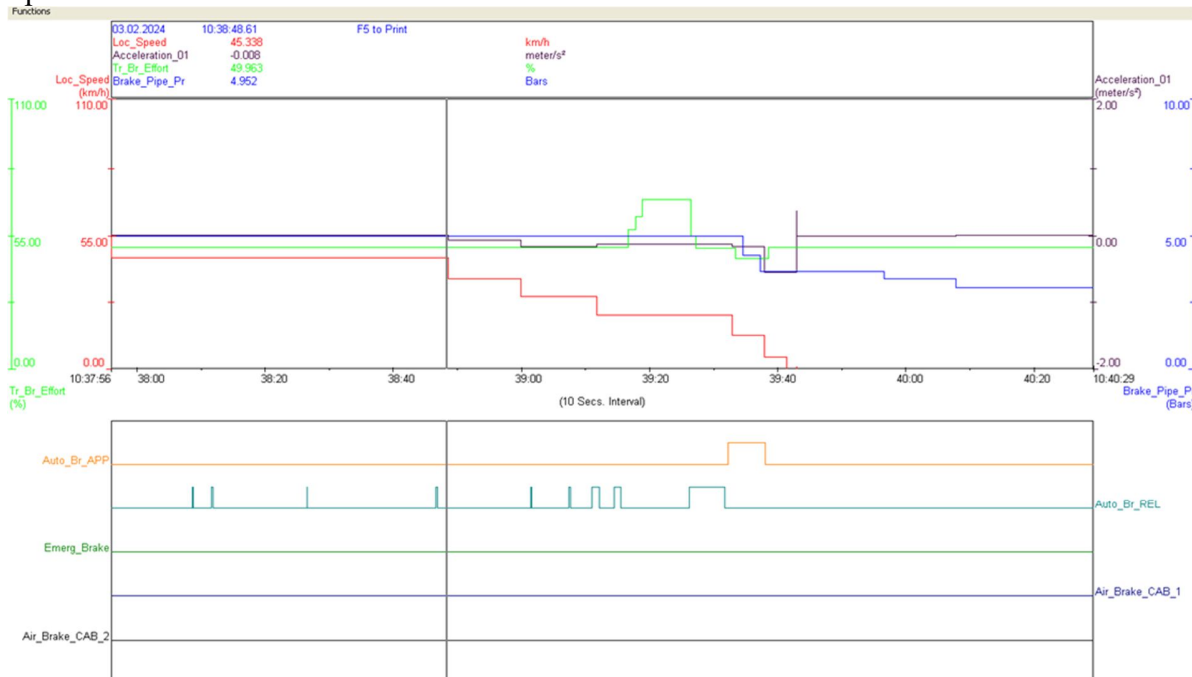
Fig. 4.5.

With a speed of 53.95 km/h, the train moved until 10:37:54 a.m., when it began to decelerate without activating the automatic train brake (Fig. 4.5). At 10:39:34 a.m. at a speed of 13.83 km/h, the pressure in the main air duct decreased due to the actuation of the automatic train brake by the locomotive driver (Fig. 4.6). IDFT No. 46660 settled in Radnevo station at 10:39:42 a.m. (fig. 4.7 and 4.8).

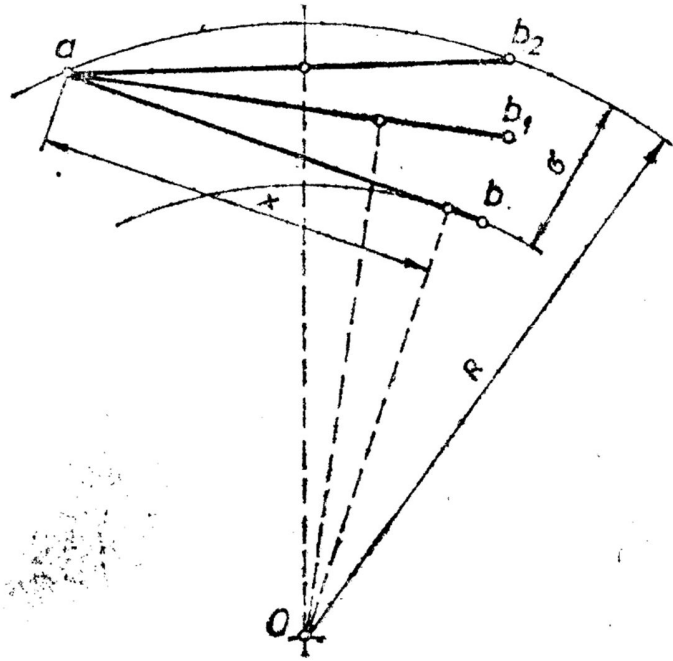
Fig. 4.15.

Simultaneously, the wagon moved in a curve. Calculations show that at a speed of 54 km/h and a base of the wagon  $2l = 10$  m, the rear wheelset occupies a position of maximum crossing (Fig. 4.15).
