AIR, MARITIME AND RAILWAY ACCIDENT
INVESTIGATION NATIONAL BOARD
9, Dyakon Ignatiy Street, 1000 Sofia, Bulgaria

Ref.:
AAIU-2022-04

SERIOUS INCIDENT, OCCURRED ON NOVEMBER 17, 2022, INVOLVING A319-111 AIRCRAFT, REGISTRATION MARKS G-EZBV, OPERATED BY „EASYJET“, RELATED TO THE LACK OF PRESSURISATION DURING CLIMB

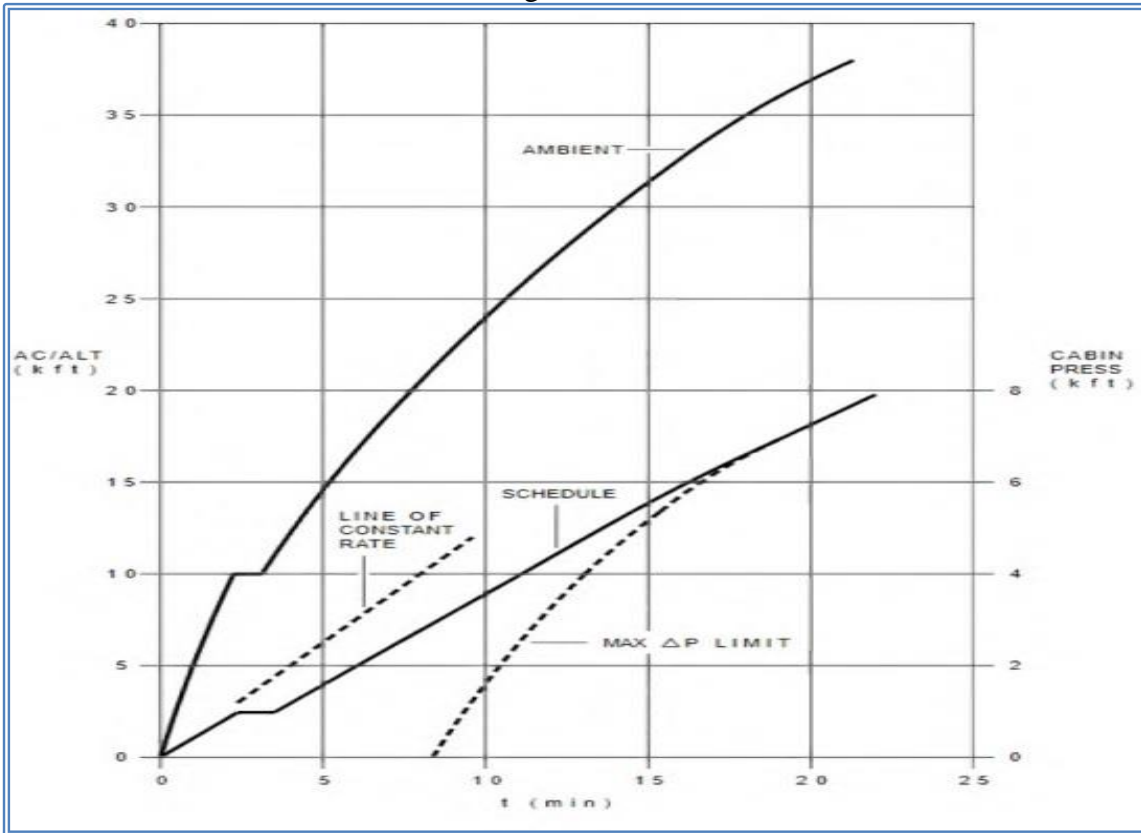
Fig.2

As shown in the AMM figure 21-31-00-15000-00-A below, during a typical climb the cabin altitude rate would be around 400ft/min on average.

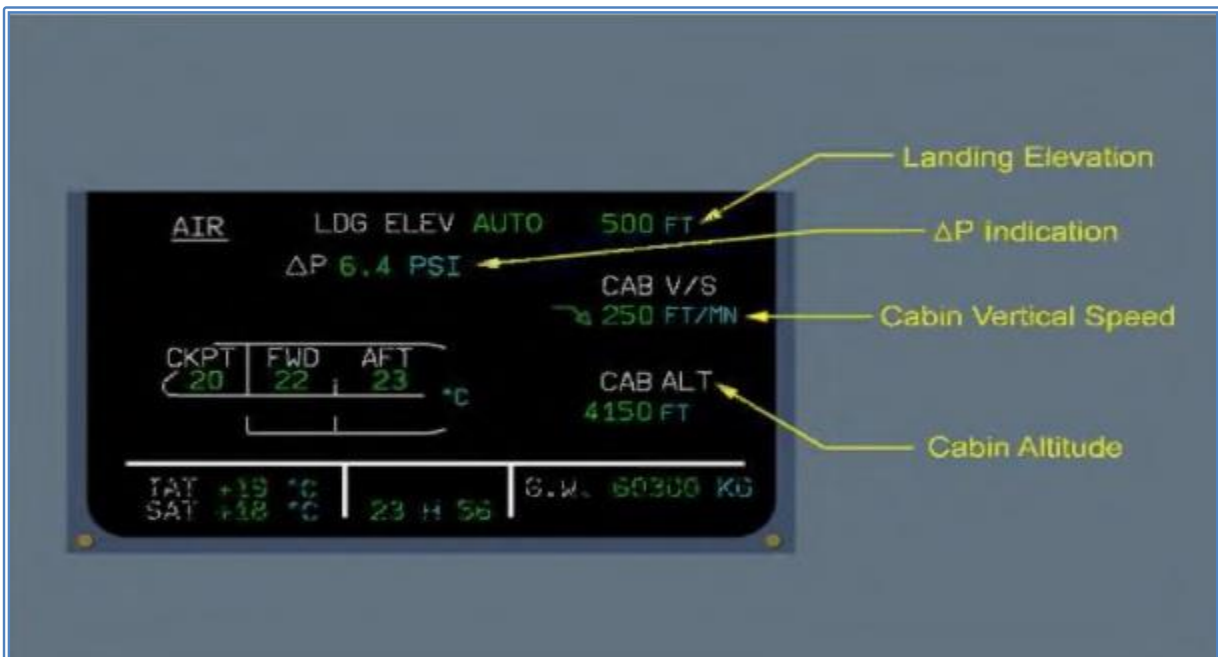
Fig.3

The cabin vertical speed (CAB V/S) flashes green when it reaches 1750 ft/min and stop flashing when returning below 1650 ft/min.

The cabin altitude (CAB ALT) flashes green when it reaches 8800 ft and stop flashing when returning below 8600 ft. It is displayed in red when the Cabin altitude is at or above 9550 ft.

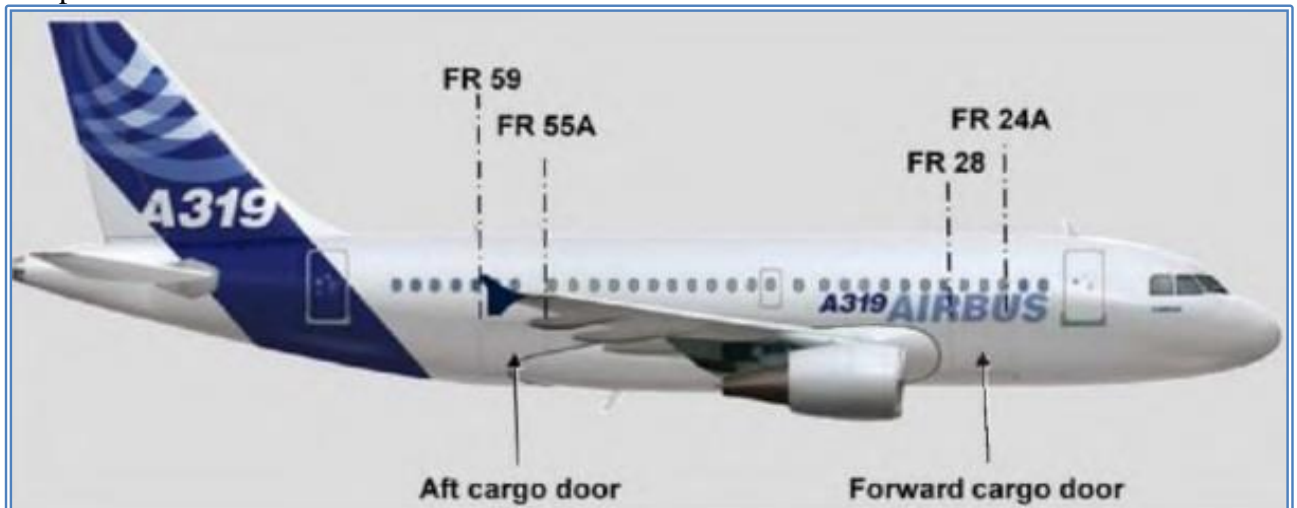
Fig.5

On the A319, there are two cargo compartment doors on the right side of the lower fuselage. They are referred to as FWD and AFT cargo compartment doors and give access to the related cargo compartment.

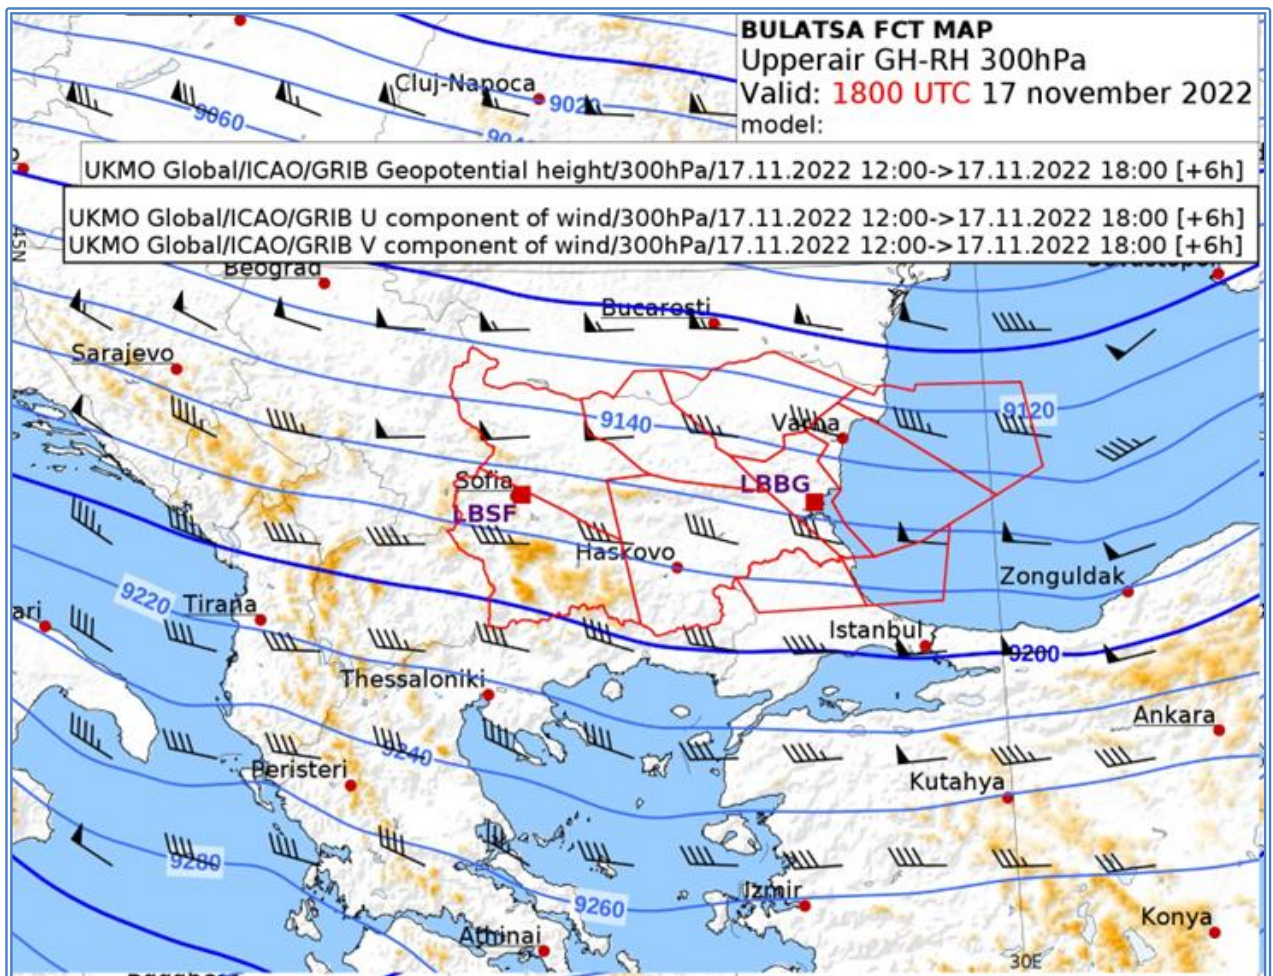
Fig.7 Wind map (in kt) at altitude FL 300

At altitude the circulation is zonal. As a result, the transport of air masses up to FL140 is oriented from the west-southwest and above FL140 from the west-northwest. At FL300, the wind is from the west 45-55kt.

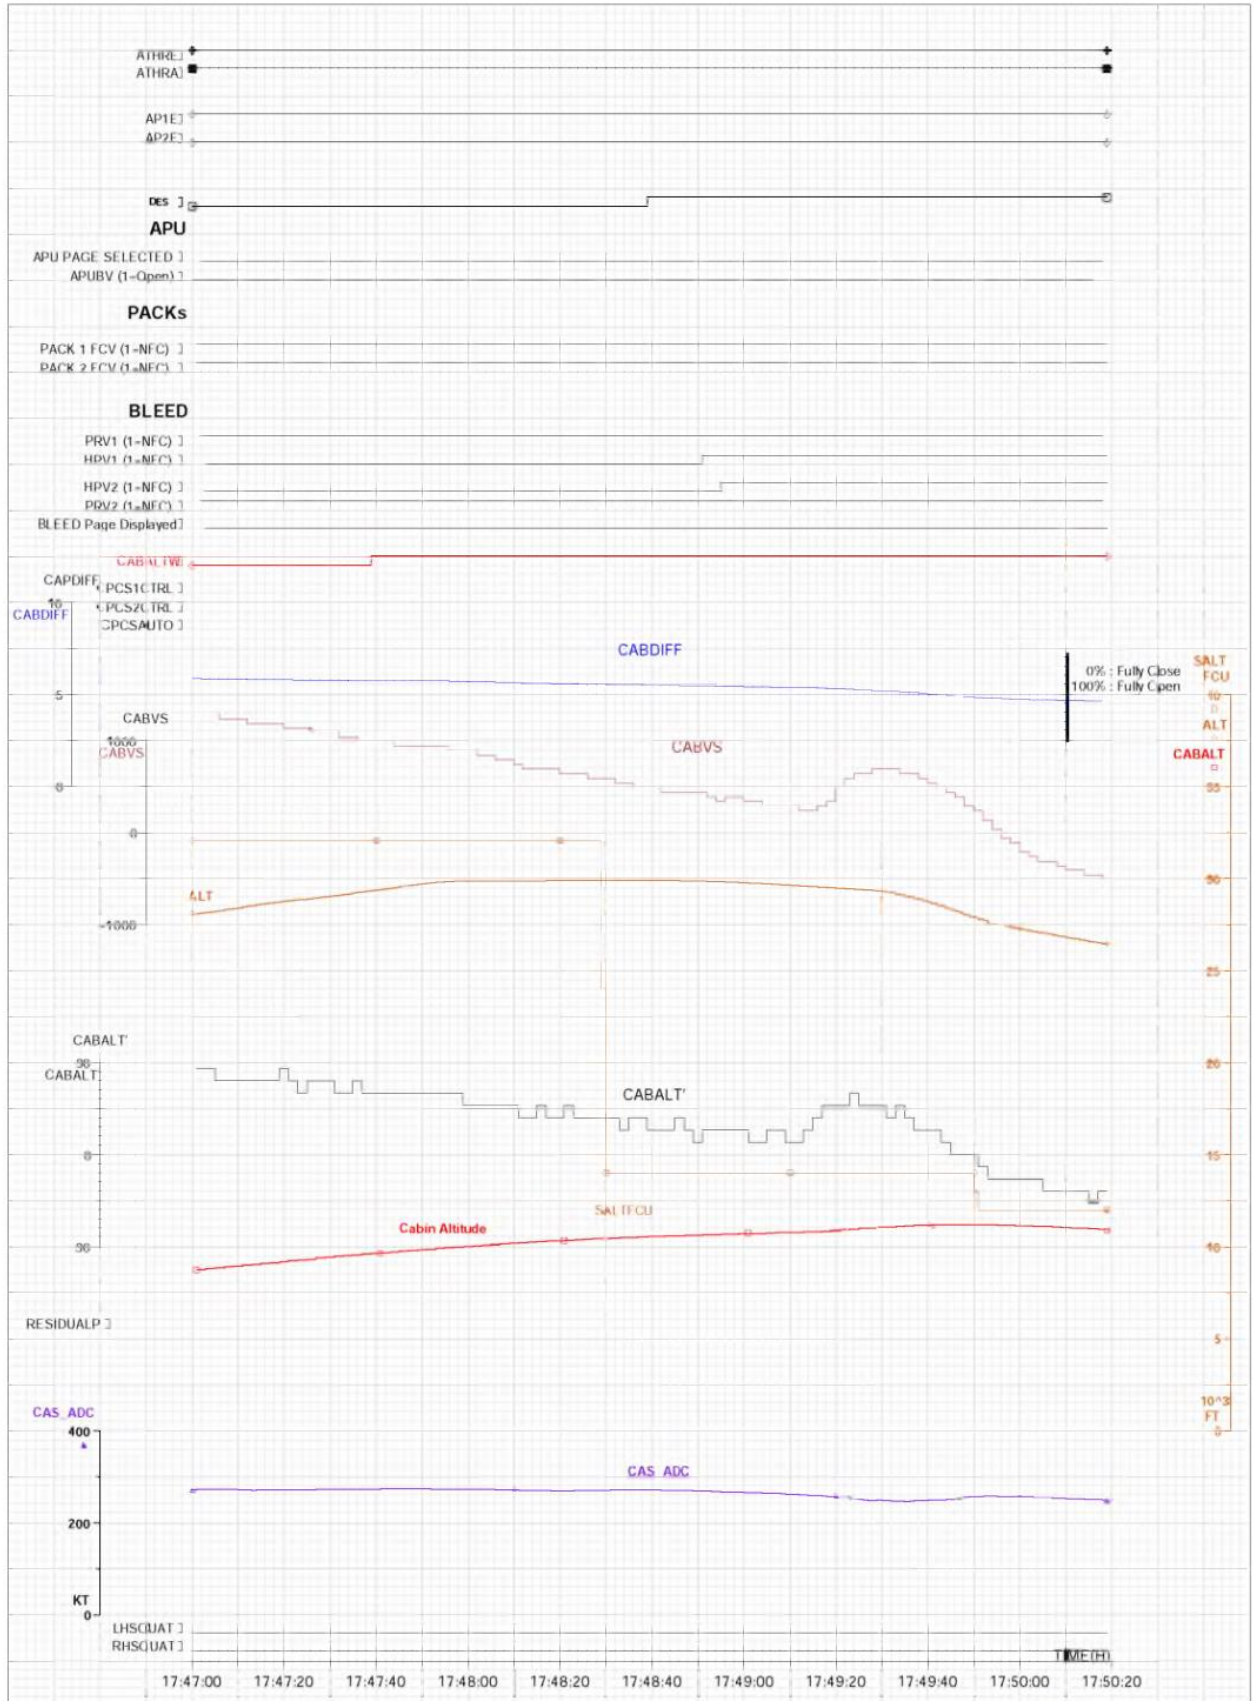
Flight And Integration Tests Centre
MR1 : N3122V9002_DAR		
ATA 21 & 36 Parameters		AT GMT START ZP - 28058 FT CAS - 272 KT MACH - 0.69 TAT - -19 DC
/workgroup/operation/dfdr/visage/Baptiste/A319/MSN3122/Cabin.ilv		Edited : 4/1/2023 Figure 1.3.5

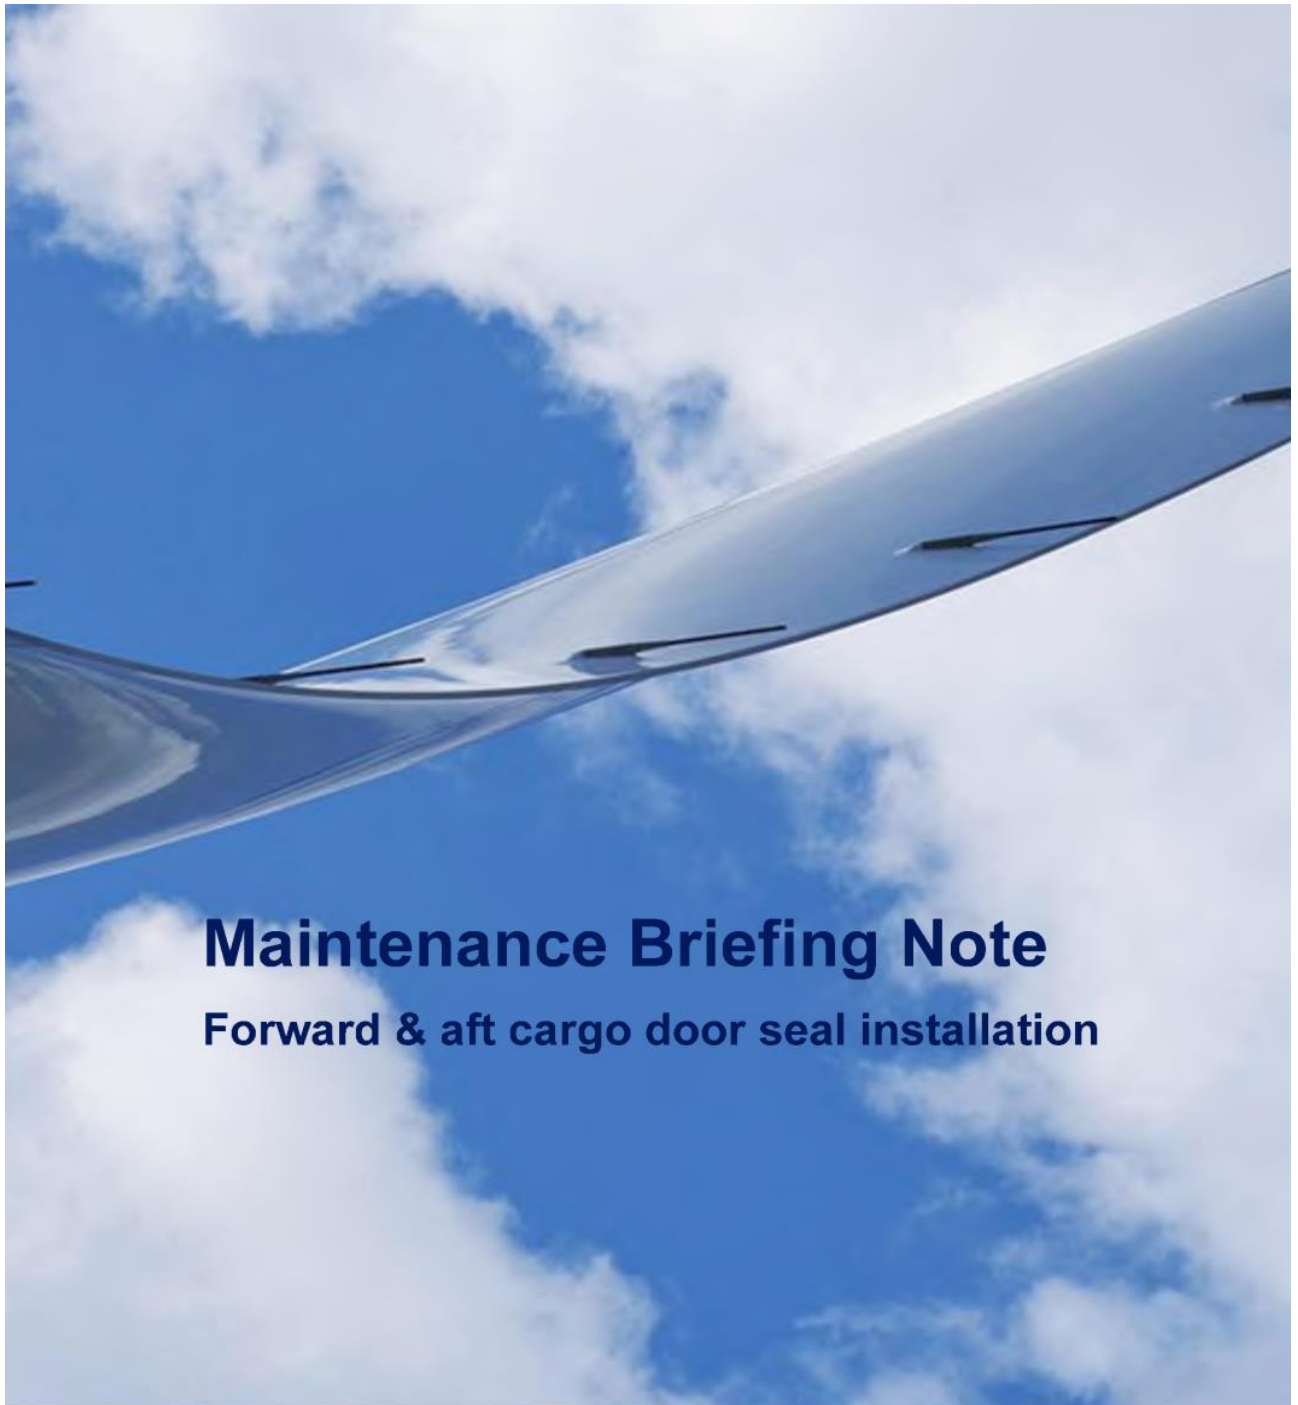
Maintenance Briefing Note

Forward & aft cargo door seal installation
